Osiligi Charity Projects

**Repair of broken hand pumps
in Kenya
FF 647**

2023 Interim Report for the Eagle Foundation

August 2023

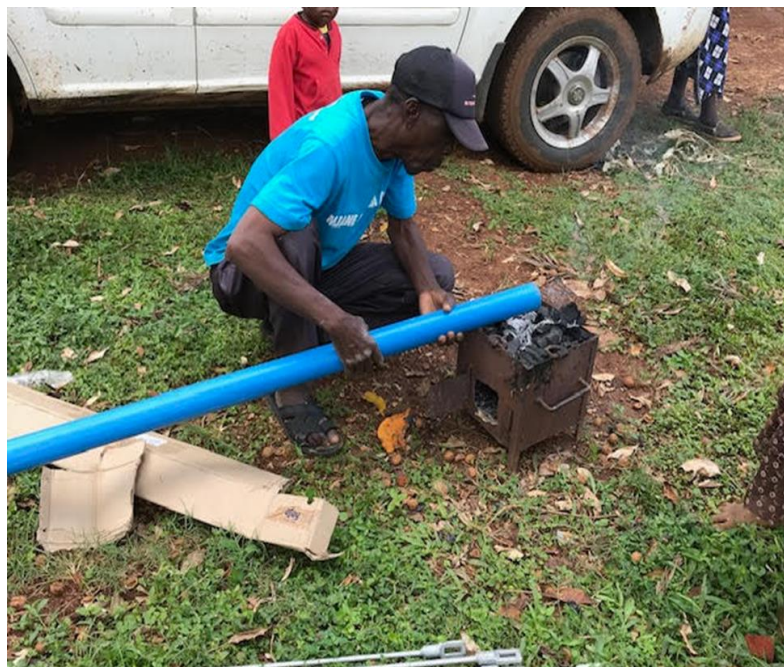
Making a joint to fit a riser.

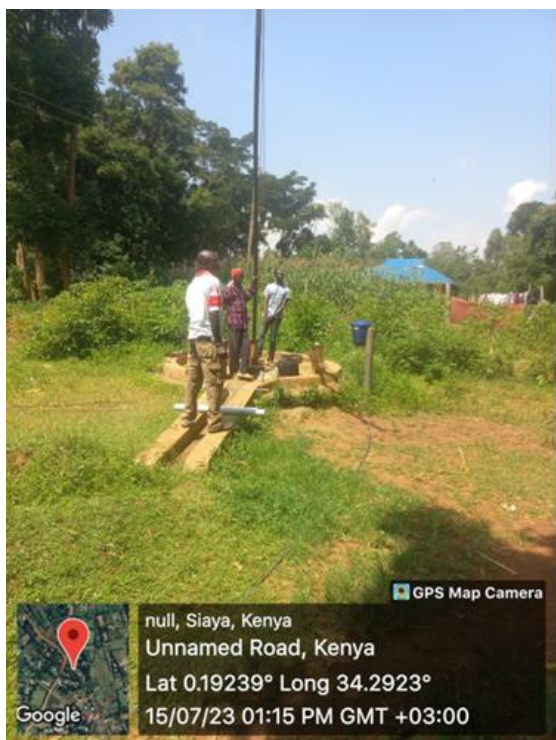
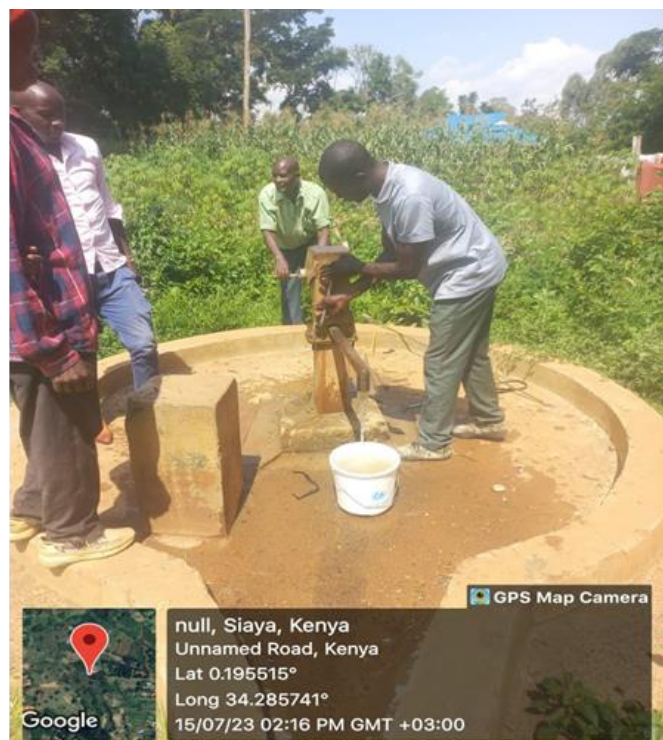
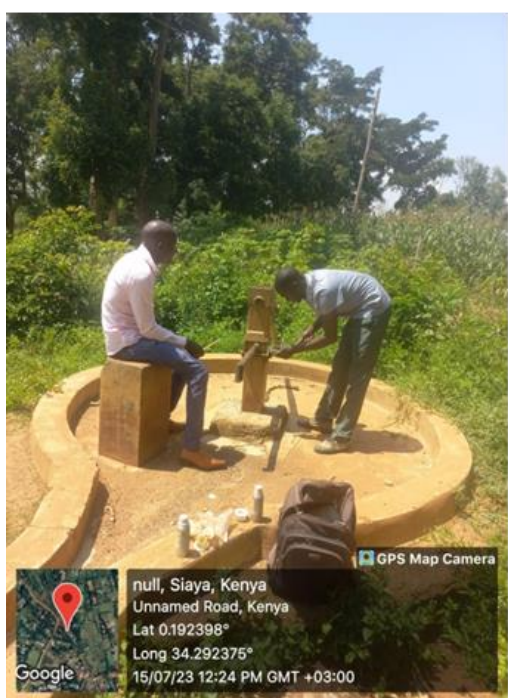
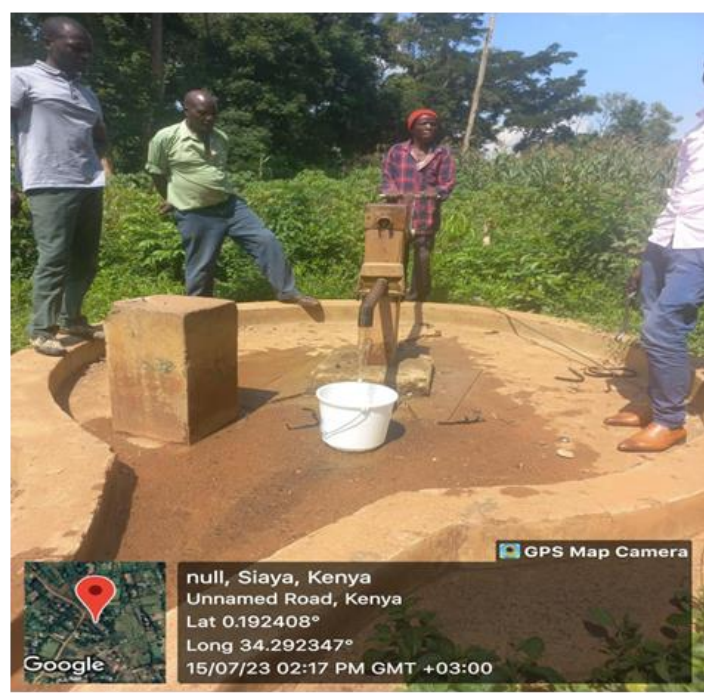
A typical hand-pump repair, restoring access to water.
