Osiligi Charity Projects

Repair of broken hand pumps in Kenya (FF 0465-25)

Final Report

For the Eagle Foundation
November 2019

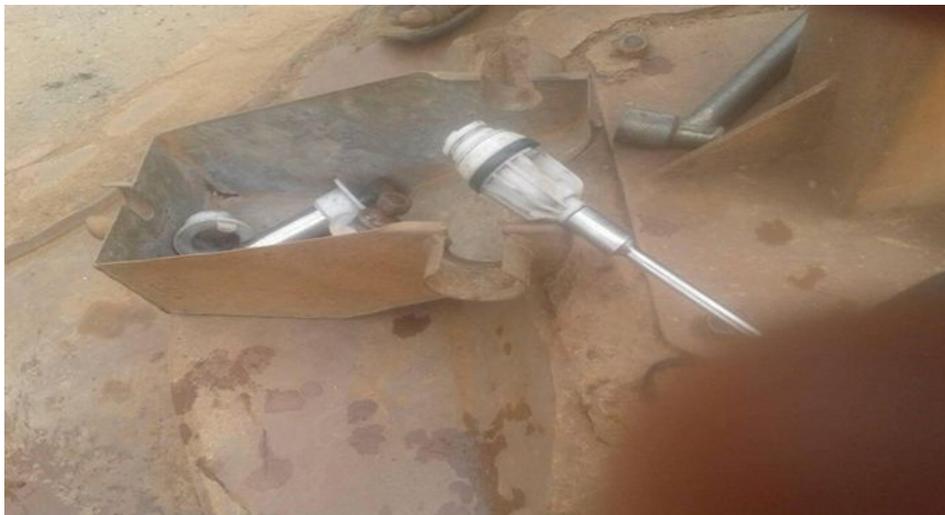
The black rubber seal on the piston needs replacing every 2-3 years, depending on use.

When we service a pump, we replace all the rubber parts and the bearings.

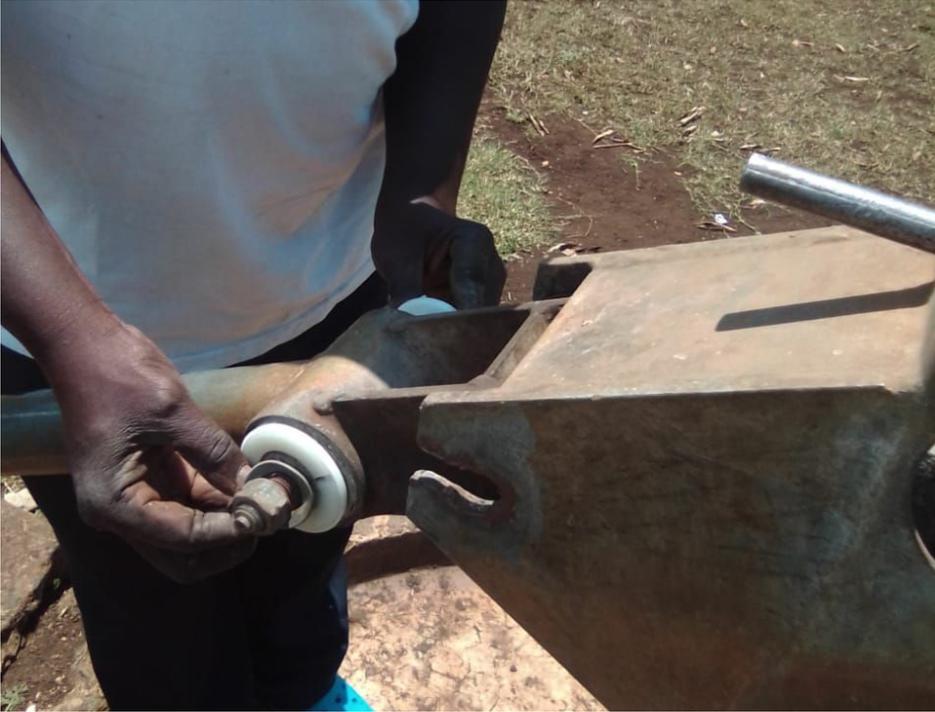
The nylon bearing in the handle and rod need replacing every 3-5 years depending on use.

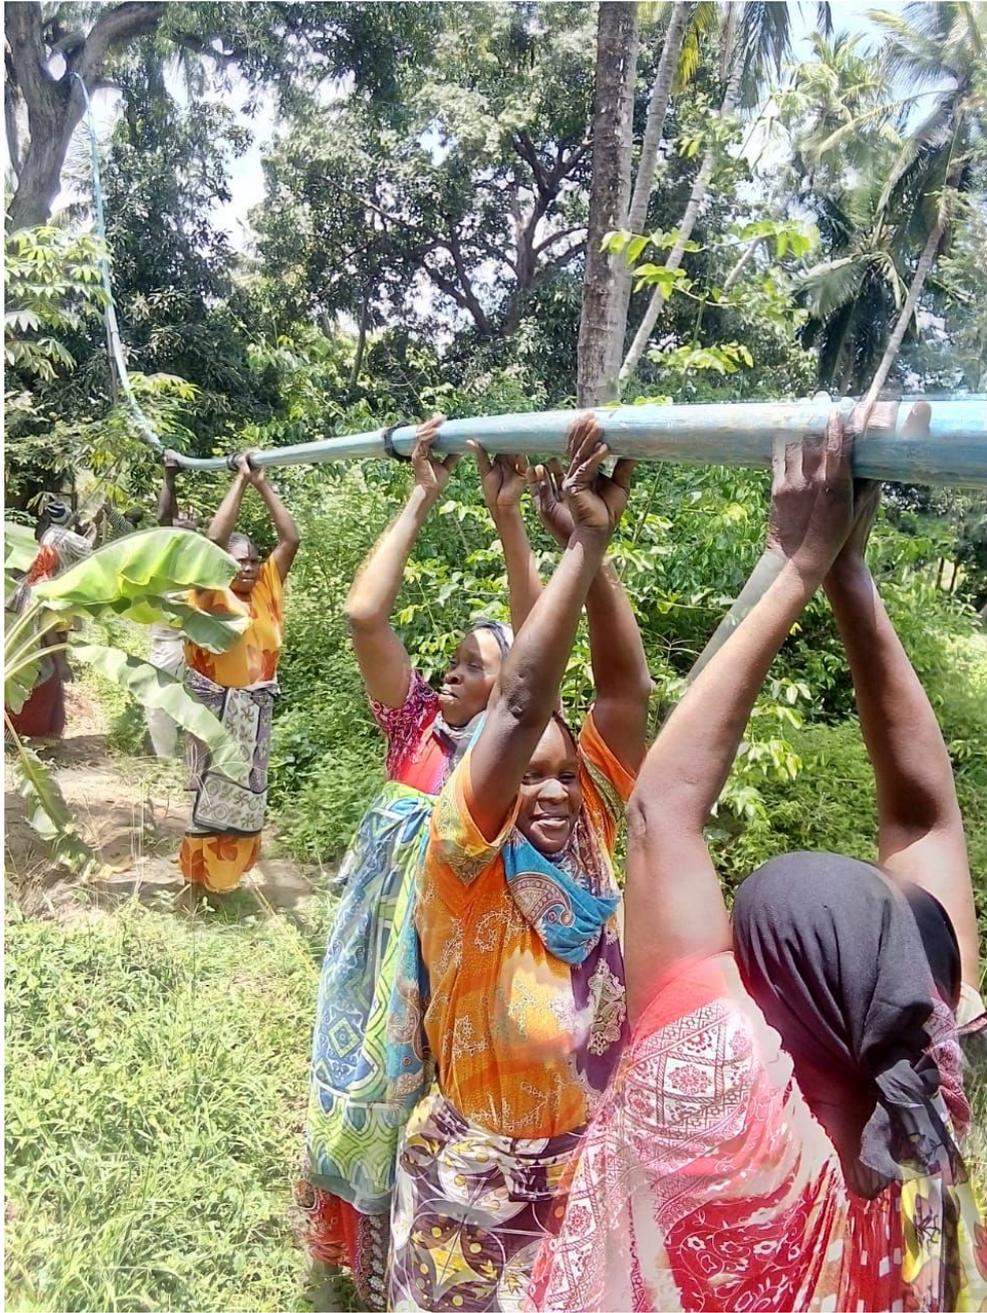
The community helping to support the pipes during removal.

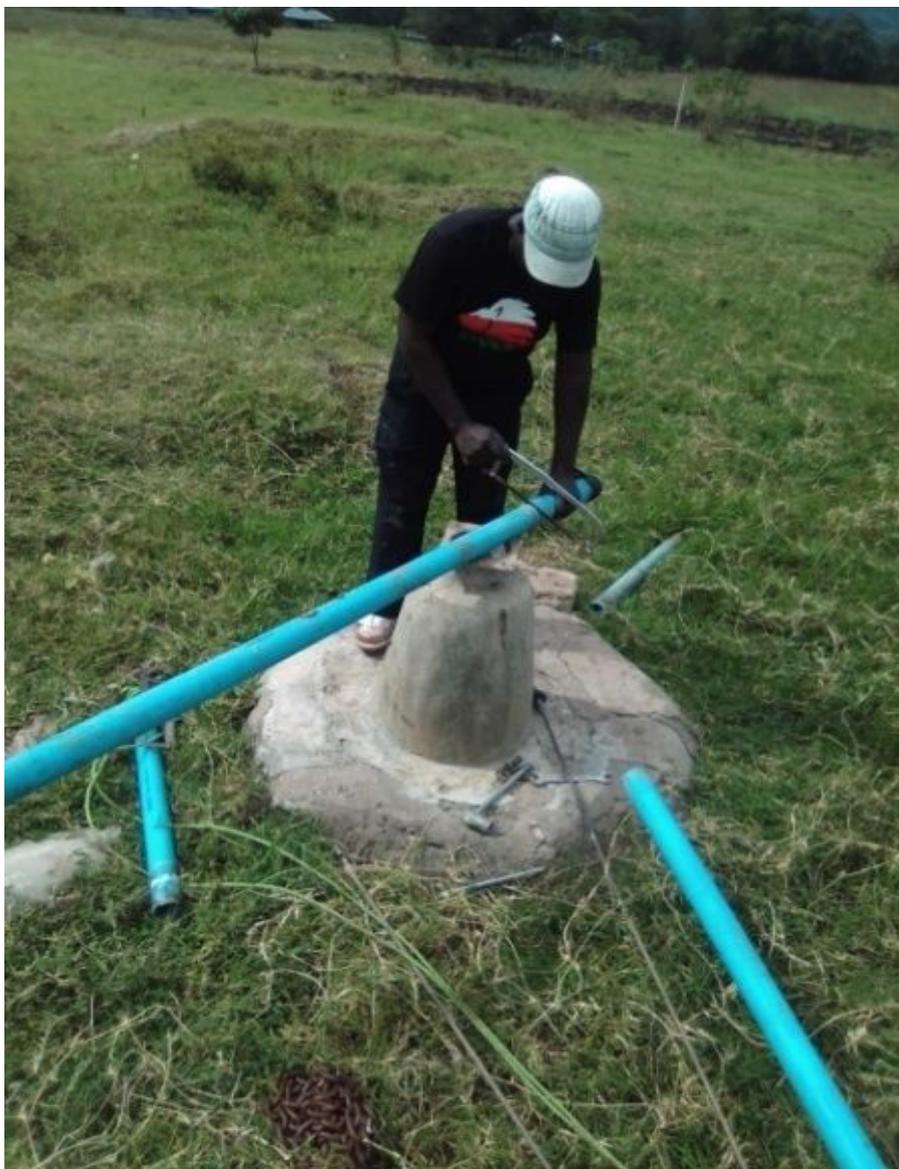
Repairing a split pipe. The split part is cut out and the pipe is re-joined.

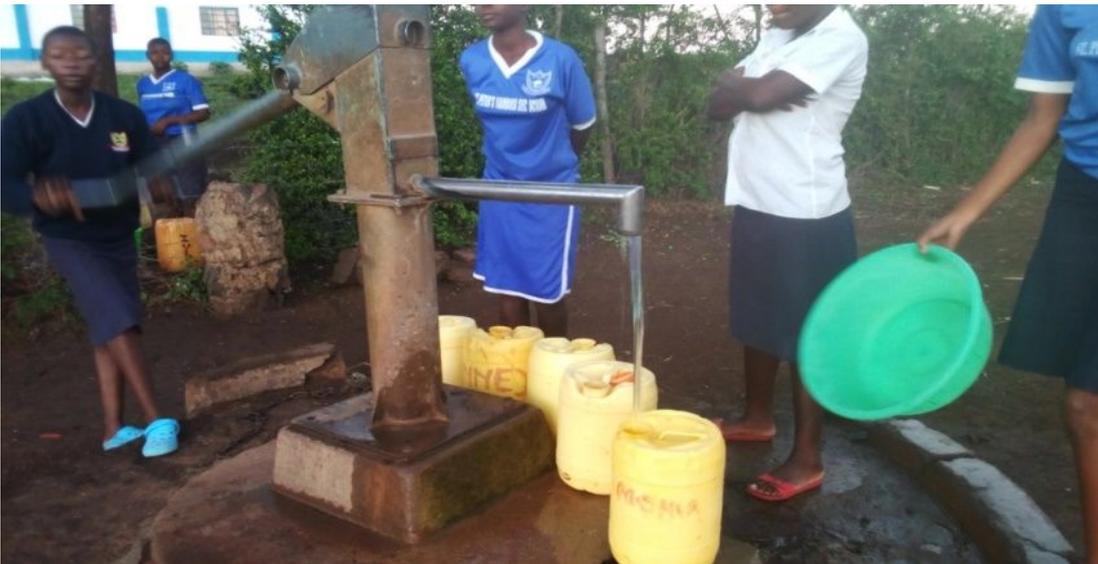
Pump repair 54 - school children collecting water after the repair.

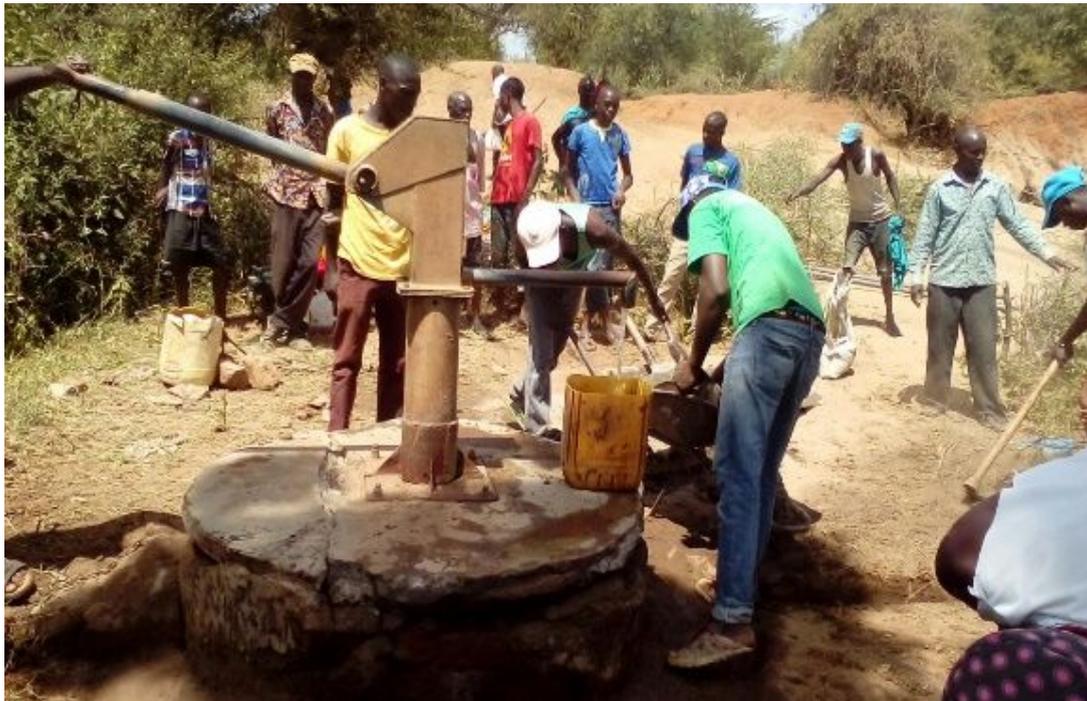
Pump repair 139 - the village pump now working again.

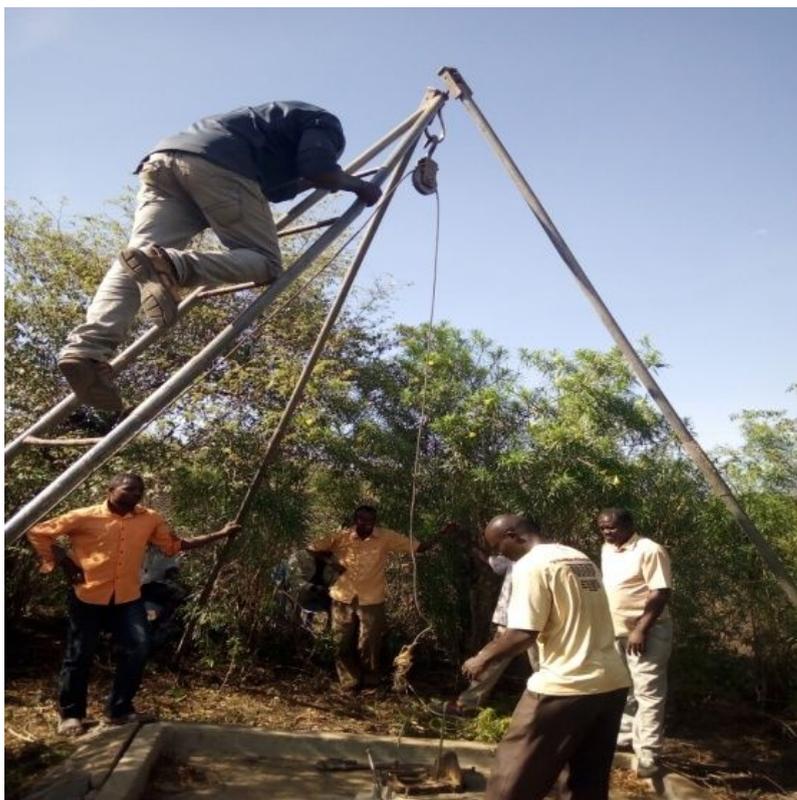
Pump repair 72 - going fishing trying to remove broken pipes. This repair is still ongoing.

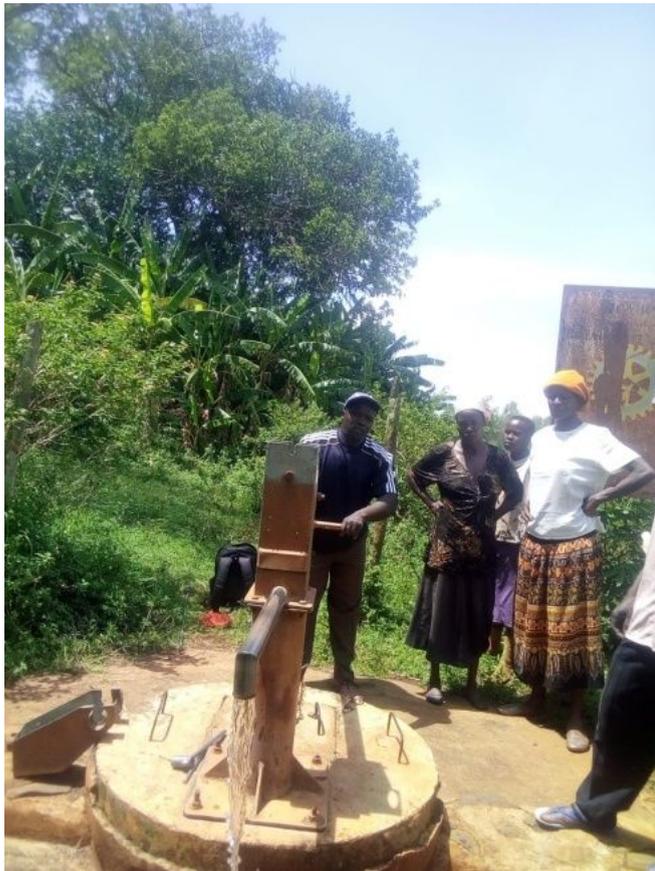
Pump repair 101 - the village pump now working again.

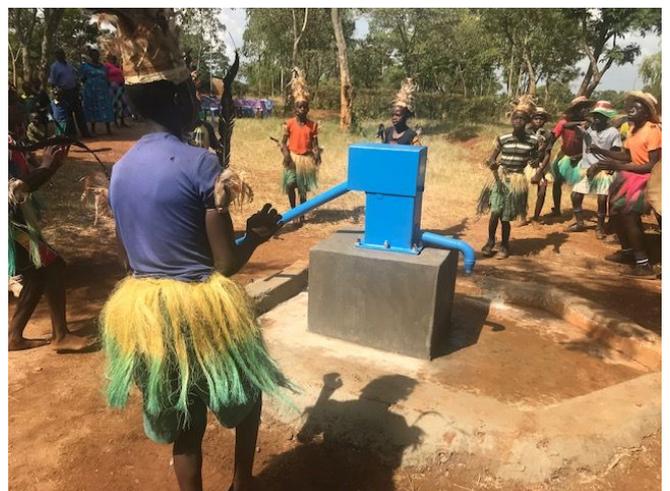
One of the new Blue Pumps installed.

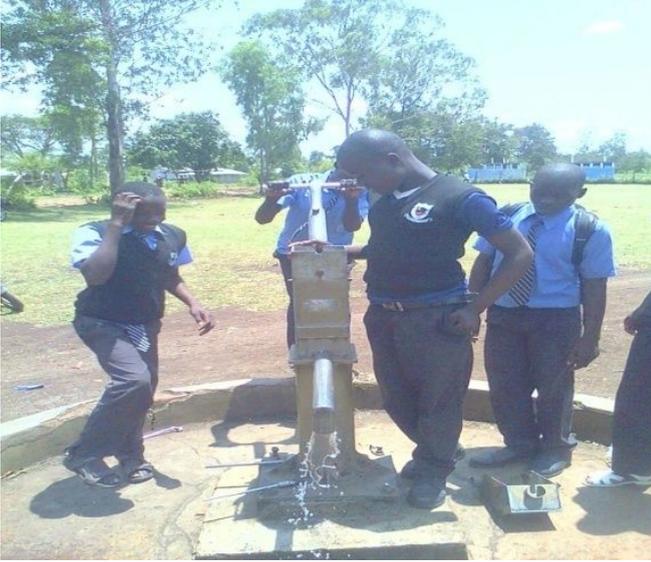
Pump 50 - school children enjoying the novelty of the working pump.

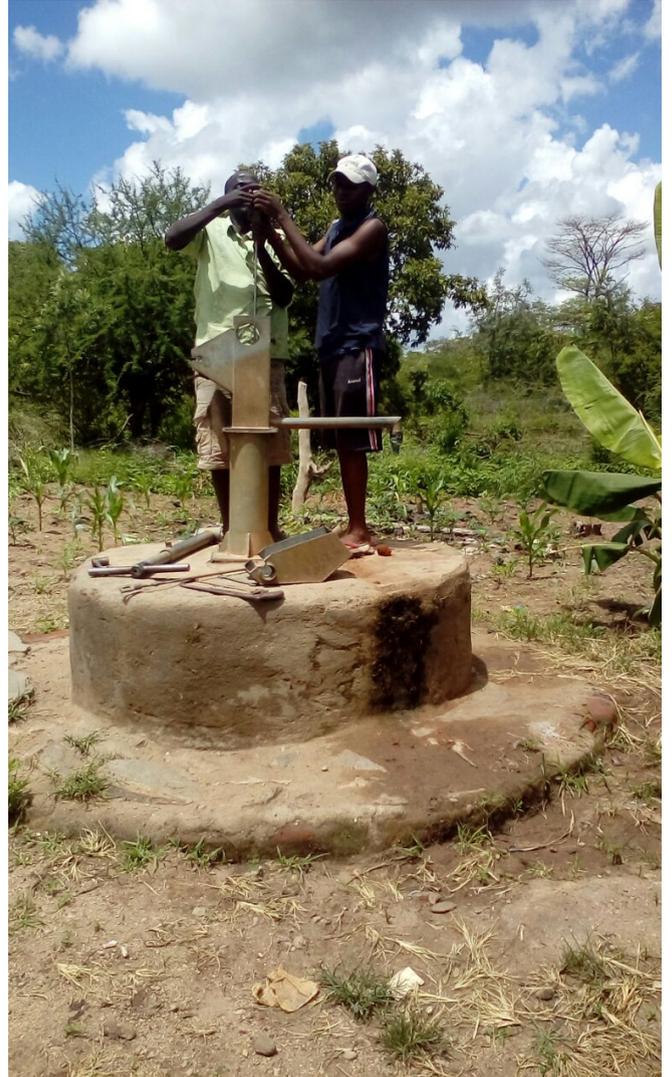
Pump 138 - being repaired - now working.
