Project Final Report July - December 2023

Donor: *Fondation Eagle*
Charity & project name: Milgis Trust – Water Projects Maintenance
File no: FF 0645
Date: 25th January 2024
Name of File: Medical and Educational Aid to Kenya (MEAK)
Amount requested: USD 25,222
Date of application: December 2022
Date of grant Accepted: December 2022

Type of Project: Funding for maintenance of 15 solar powered water projects, providing clean water for communities and their livestock.

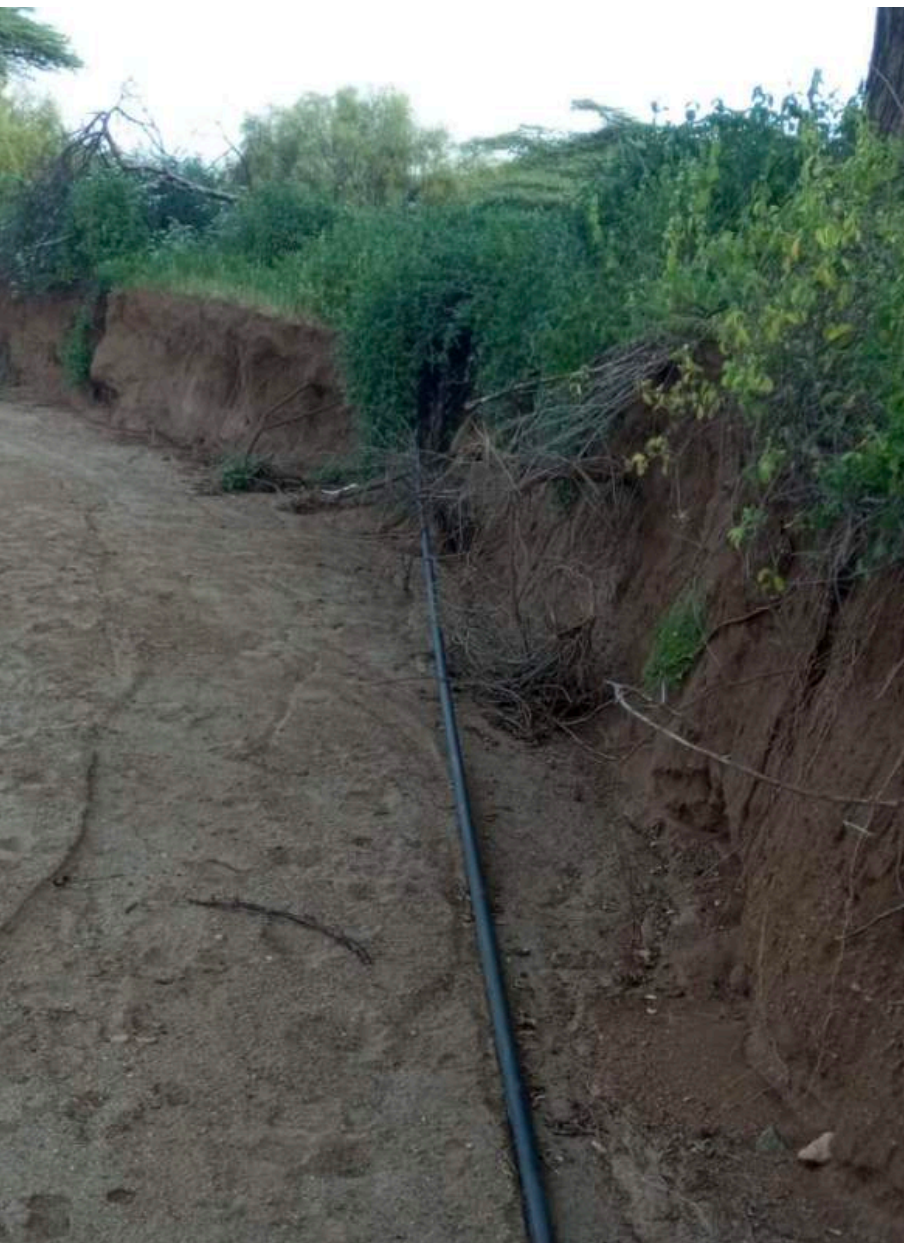
Pipeline washed away

During the second half of last year Muko did some renovations on the troughs as well as trying to prepare the water project and community well that we lined for the rainy season. Unfortunately, there was an immense flood in this valley that carried away half the piping to the community standpipe. We were able to salvage some of it however we have decided that it will be easier to just have one watering point as opposed to two in order to avoid pipes crossing the lugga.

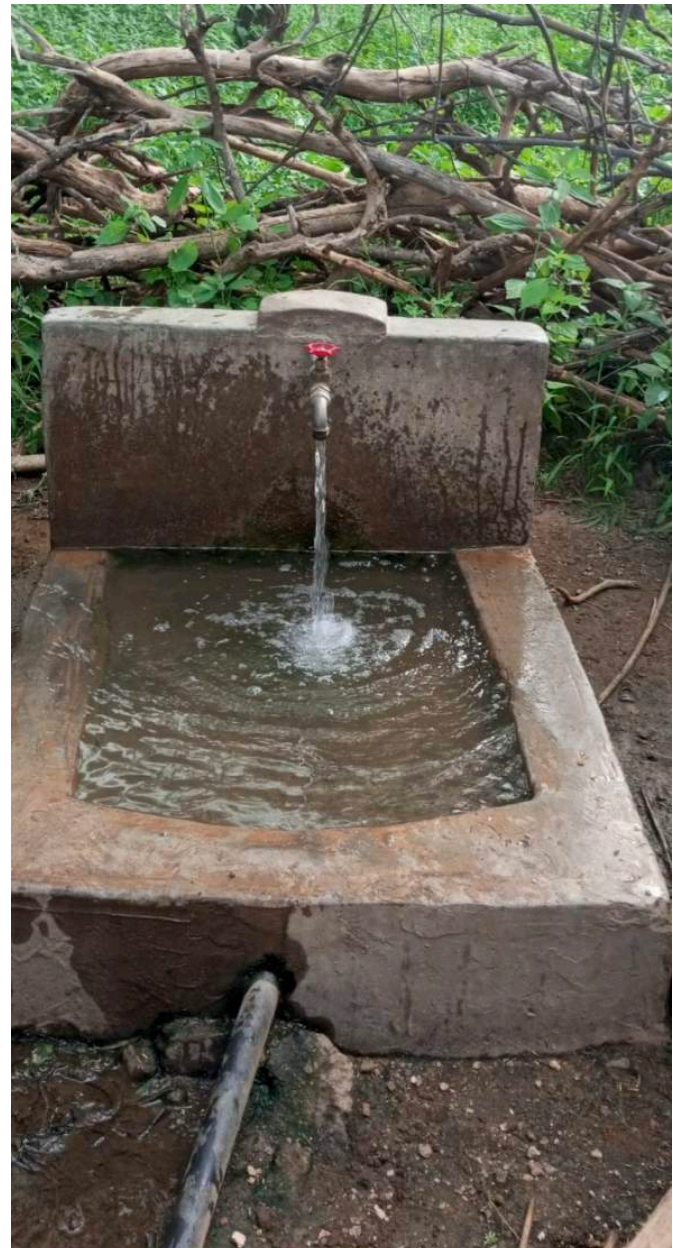
One of the standpipes to be mended, new taps and some leaks to fix

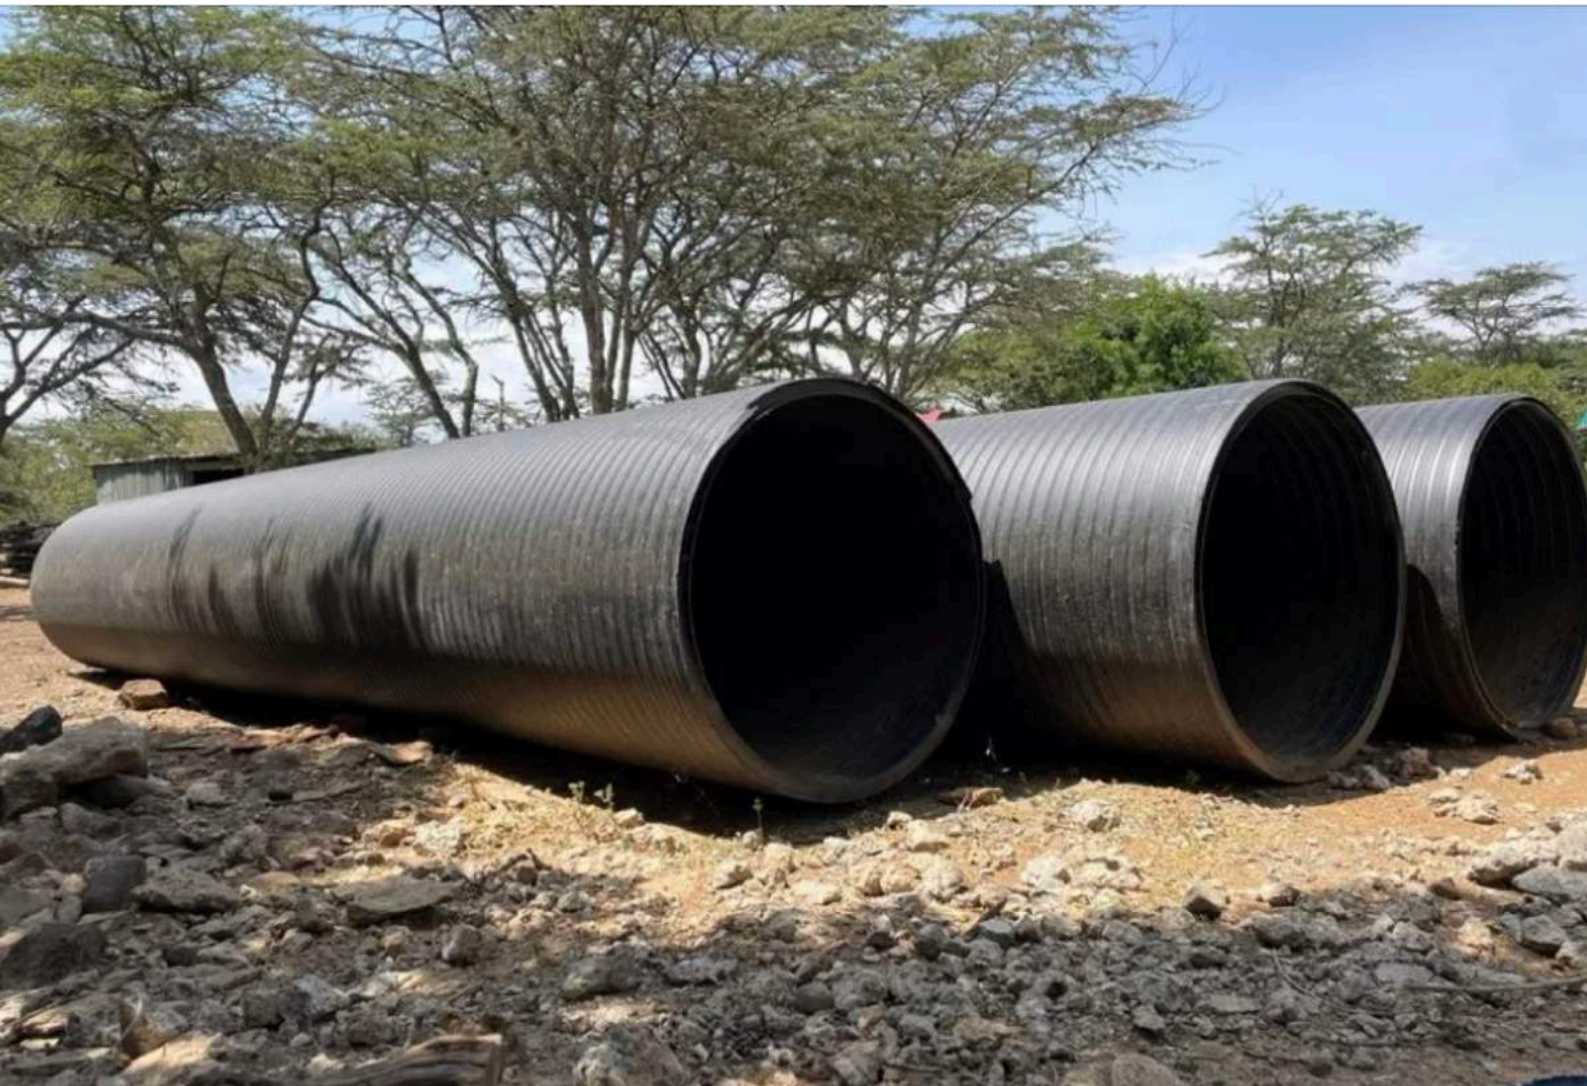
Heavy Duty PVC well linings delivered to site.

This is a big job as these PVC linings are extremely heavy and had to be transported to site using a 6x6 all-terrain lorry. Them from the lorry to the site of the well is a very rocky pack that requires a big effort to carry these by hand. Needless to say, the hard work will pay off as these linings should keep the well intact for a lifetime.

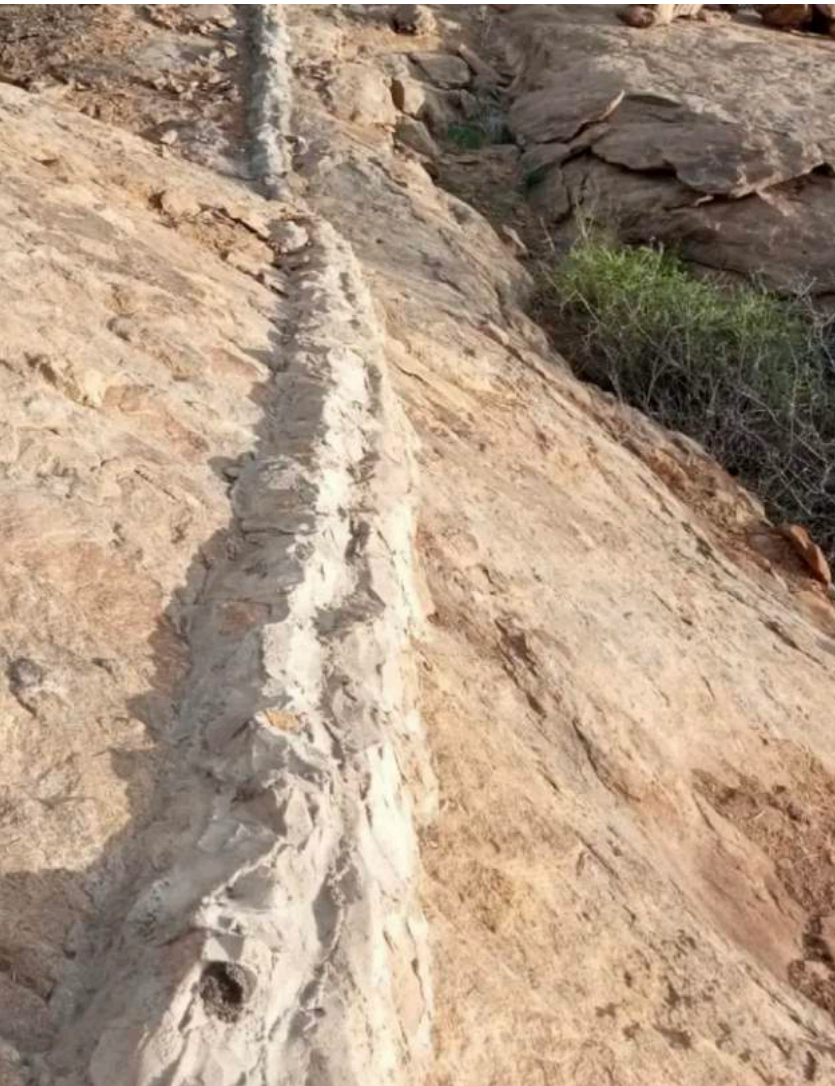
'Elephant Proofing' the pipelines over rocky sections

The new trough that was built also had significant issues with it. We found that sections of the foundations had been undermined by water, caused by elephants disturbing the pipes nearby. So to sort it once and for all we ended up carrying out a heavy duty, slightly excessive reinforcement which should stand the test of time even with all the pressure from elephants.

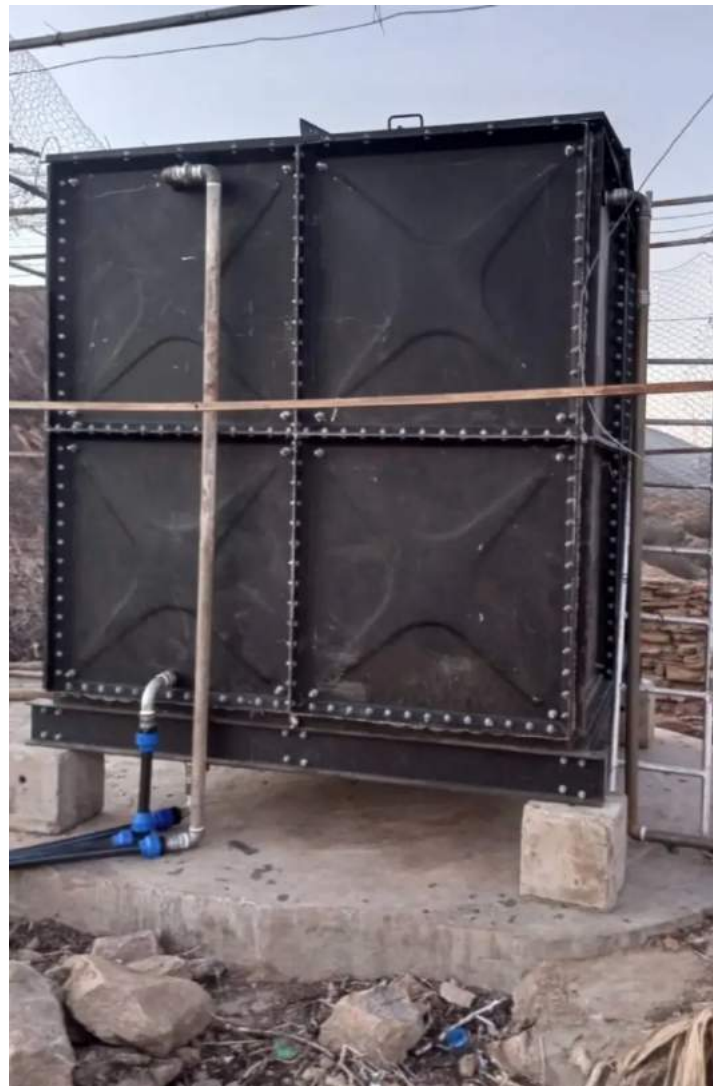
The tank prior to painting

This project had a lot of work done early last year, including a new trough built, and installation of the galvanized steel tank and also extra protection of large sections of pipeline that traverse across rocky areas. During the second half of the year our team refined the system that splits water equally between Mpagas and Marti Derop communities, ensuring that neither party can deplete the others water, which had been a problem in the past.

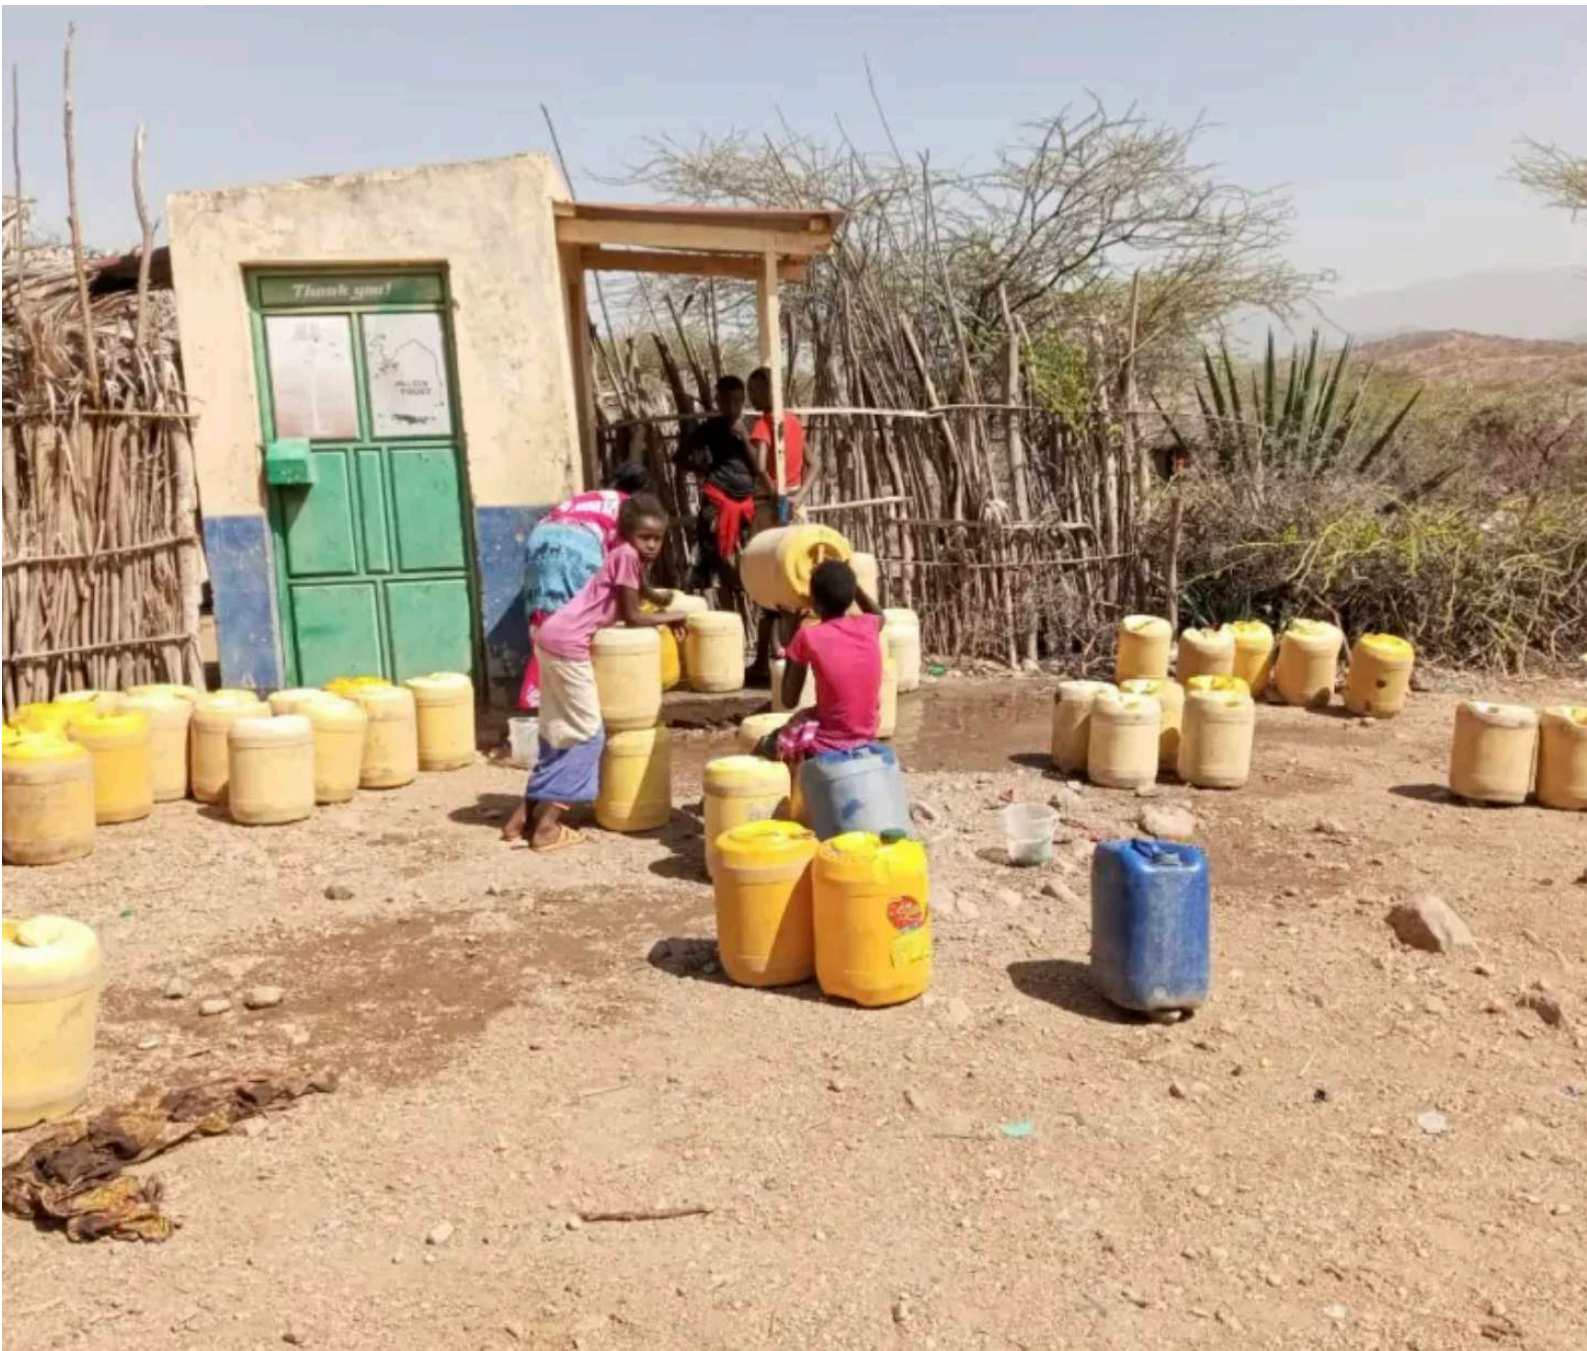
Latakweny community standpipes

Latakweny is a small town near our headquarters. Earlier in the year we had replaced the tank that had cracked due to long term sun damage. Fortunately, we had replaced this and the project was running smoothly. We did however need to carry out some smaller maintenance tasks on the standpipes, and replacement of fitting throughout the system.

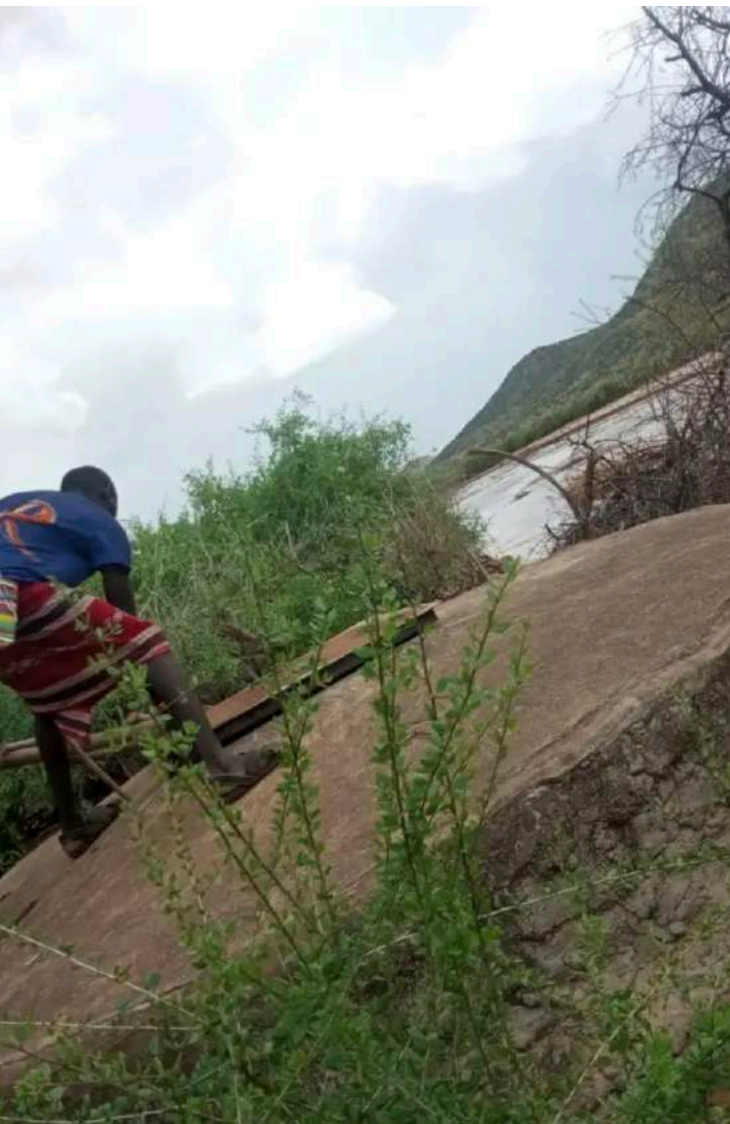
During the May rains, the well nearly got washed away due to the lugga changing its course, and with only a couple of metres to spare before the edge of the lugga we decided it would be best to re-locate the well before the El Nino season. The digging of a new well is not easy but after several weeks, we succeeded. The new setup included the new PVC well lining, a brand new re-enforced well cap shaped to withstand the floods. With an added few metres of height from the lugga we hope this will remain intact for many years to come. The project is working at maximum capacity again.

The old well , with lugga behind

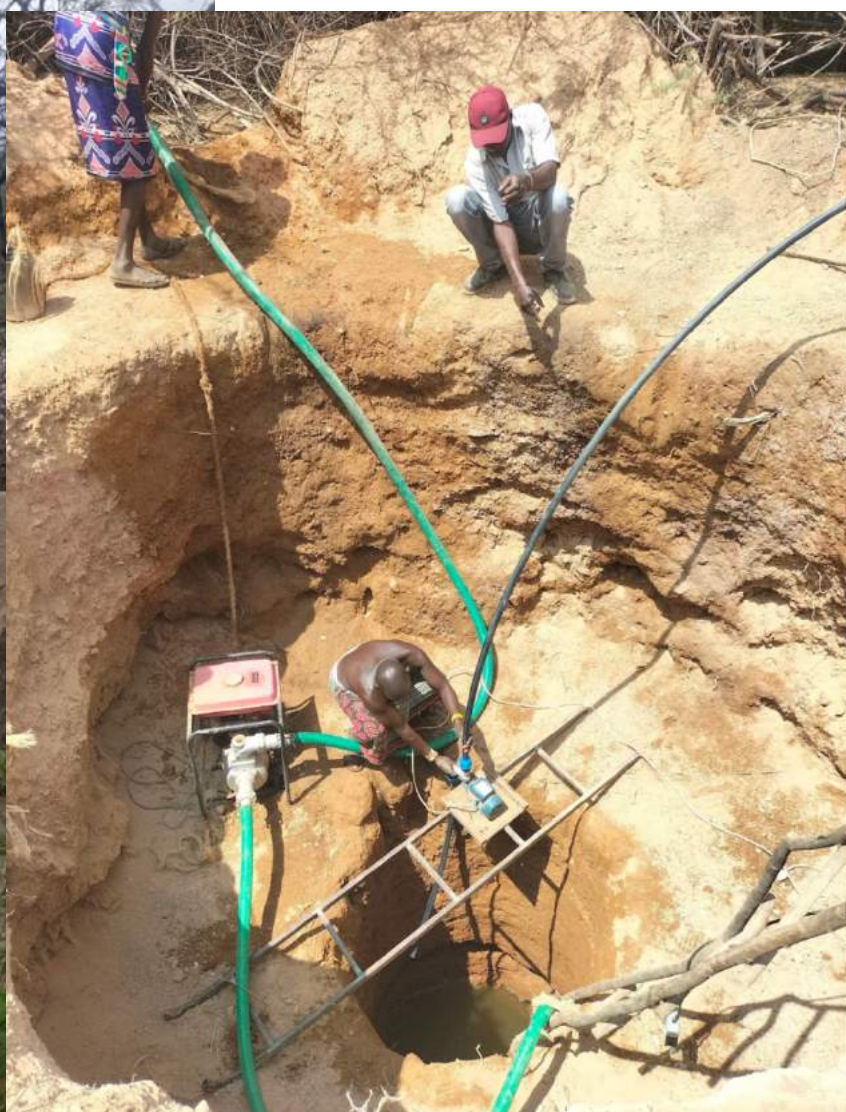
The immense job of digging a new well

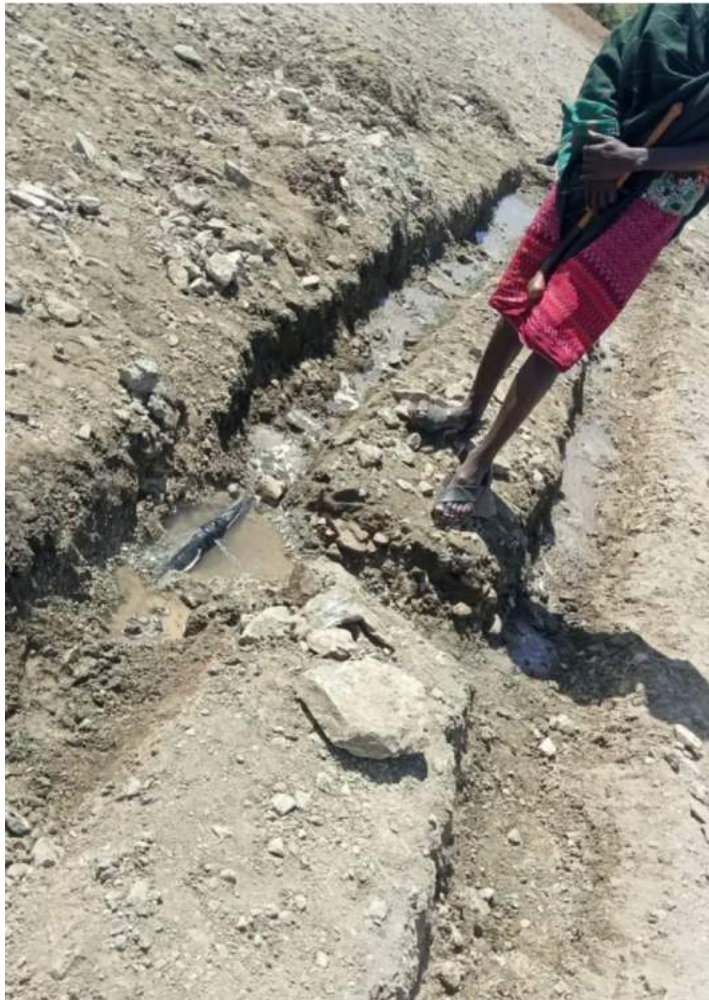
Simiti is a small village to the west of the Ndoto mountains, it is a very dry area and solely relies on this project for water. It has been extremely successful over the years with few issues since implementation. Unfortunately, recently the county government was carrying out some work to put in a trough and in the process severely damaged our piping network. There was no consultation and we were not aware of this work.

One of the damaged sections

We were forced to re-do large sections of piping and redo some cement work..... A typical example of people coming in to do 'one shot wonder' projects. The community have since had several meetings and insist they will not allow our projects to be interfered with again.
