**Construction of a new school building for the
Tanakambana Secondary School in Madagascar
(FF 00359)**

Final report

October 2016

**Feedback Madagascar/Ny Tanintsika (FBM/NT) –
The Eagle Foundation**

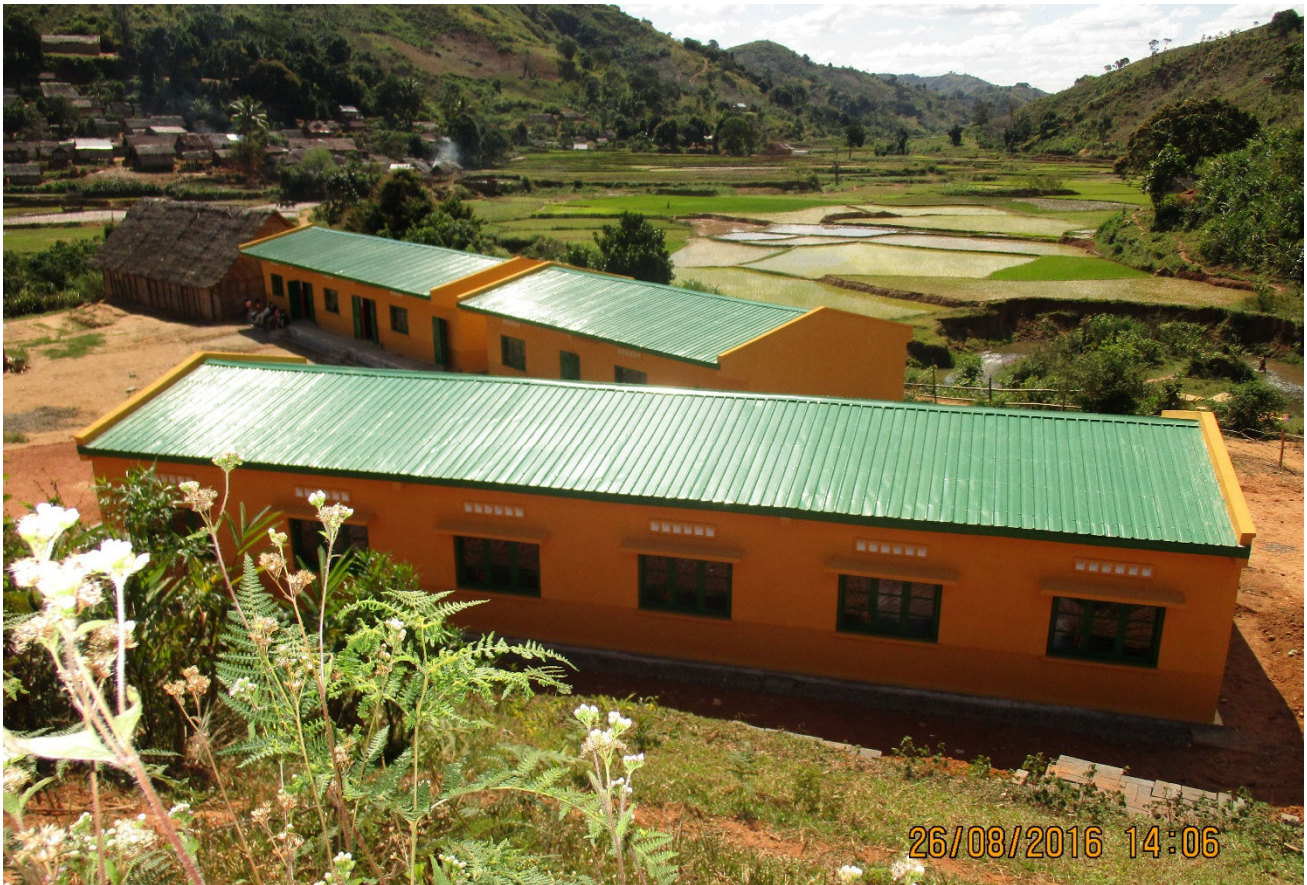
Figure 4: View of the completed 3 buildings (before installation of guttering).

Features of the new school building are as follows:

- Building three buildings: Two buildings of 3 classrooms, measuring 21.88m x 7.94m x 4.4m, and one building of 2 classrooms measuring 14.66m x 7.94m x 4.4m.

- Stone foundations and cement breezeblock walls with a reinforced concrete structure.
- Cement rendering on inside and outside walls.
- Cyclone-proof tin roofing.

- Double metal doors with hooks to hold them open on the outside.
- Each classroom with 3 windows. Windows with glass panes, opening to the inside with protection grill on the outside.

- Front and back guttering on both buildings with an additional downpipe in the middle of the 3-classroom buildings due to heavy rainfall in this area (to prevent damage).

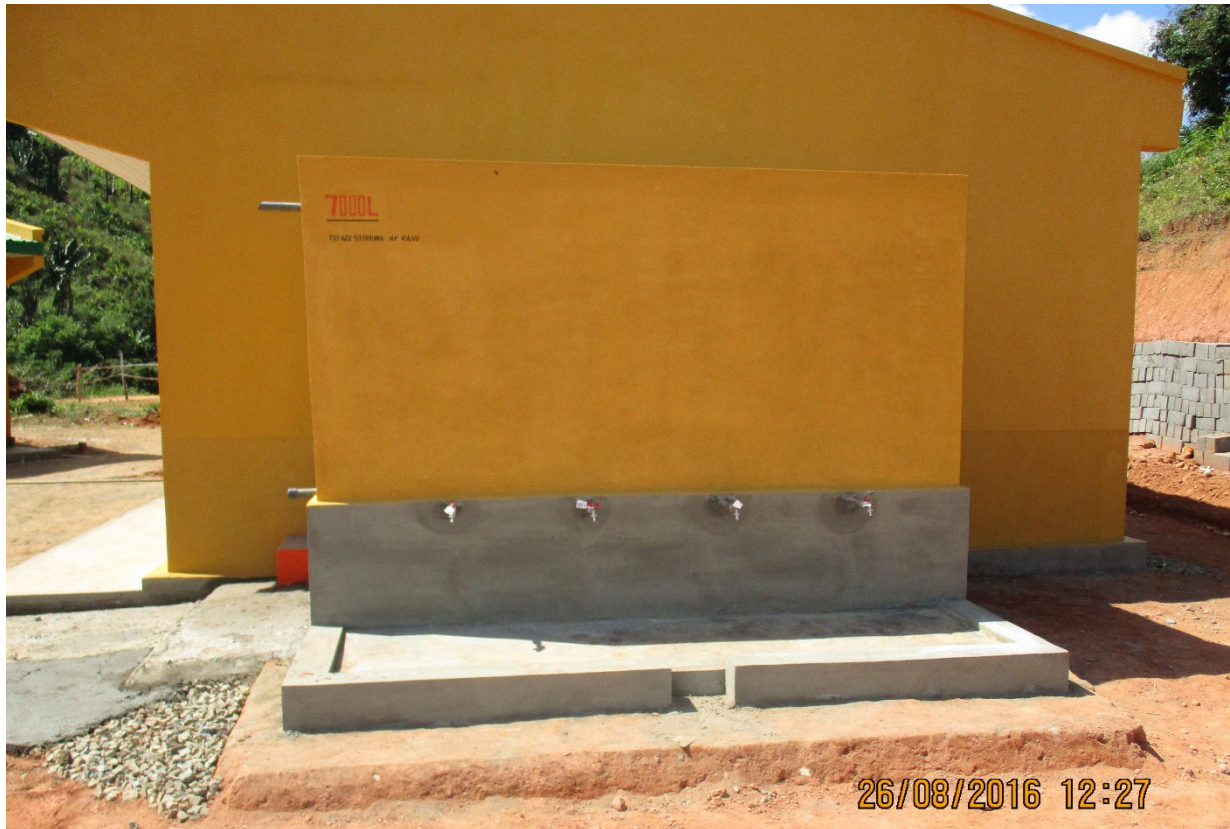
Figure 5: The water tank and hand-washing station (before installation of guttering/down-pipes).

- Building guttering linking to a 7m³ water tank for rainwater serving as a hand-washing station to the side of the building, connected to 4 taps. The system is raised-up to be at a convenient height for hand-washing. This is located between the latrines and the school to promote hand-washing at key moments. The tank is equipped with a manhole cover on the top to enable cleaning as well as refill during the dry season, with steps built up to the top of the water tank.

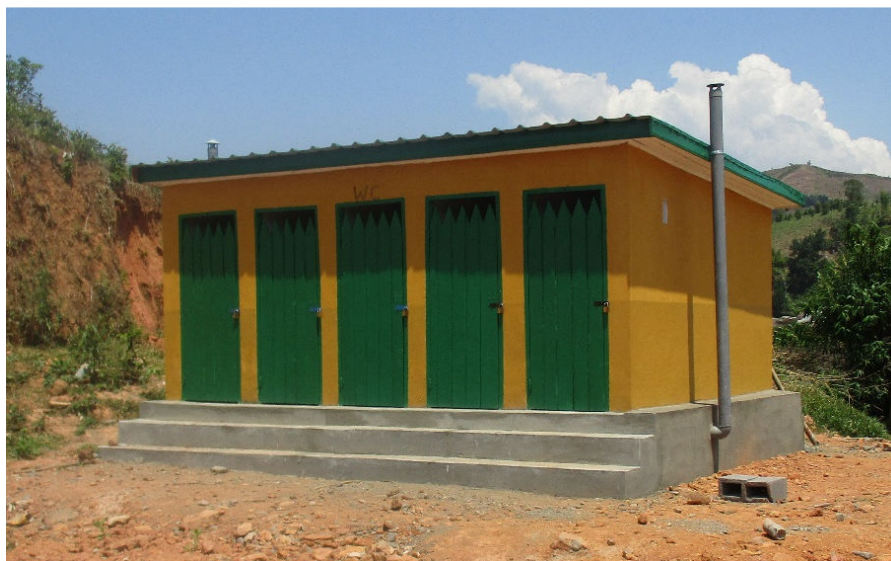
Figure 6: The 5-cubicle sanitation block.

- A sanitation block composed of five-compartments: washable and 'fly-proof' latrines (long-drop toilets with a 6m-deep hole) with separate girls/boys urinal behind. The urinals are roofed to prevent rainwater from entering the toilets (risk of damage in the cyclone season) as urine will be channelled directly into the latrine pit.
- 128 school desks with integrated benches (16 in each new classroom), 8 tables and 8 chairs for teachers.

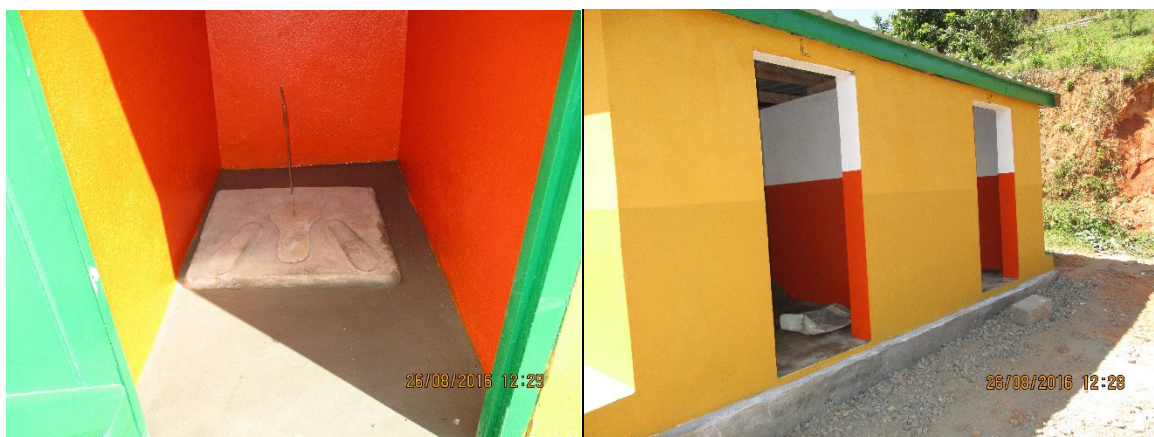
Figure 7: One of the 'fly-proof' latrine compartments (left) & girls/boys urinals (right).

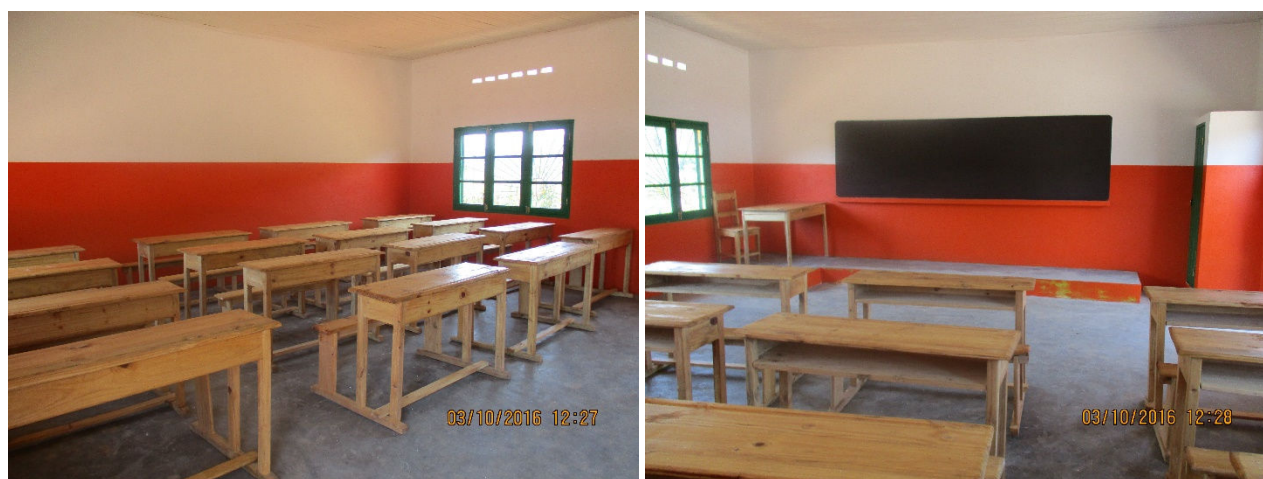
Figure 8: Interior of one of the classrooms.

- Two-tone colouring (interior and exterior); oil paint at the base to protect from dirt and water-based paint higher-up.
- Wooden pine ceiling (of classrooms and veranda) painted with oil paint.
- Concrete blackboard with concrete chalkboard and raised stage for the teacher and their desk.
- Concrete flooring.
- In-built shelving in each classroom made of bricks, lockable with a door to store books / materials or supplies.

- Installation of doors on the shelves in each classroom, so as to prevent theft of chalk, books and other materials.
- Integrating a chalk-holder shelf under the blackboard.
- Locating steps up to the water tank between the tank and the school building for safety reasons.
- Adding an additional concrete channel to drain water around the veranda.
- Provision of a tools kit for the school maintenance and repairs committee, who are a new structure put-in-place to improve maintenance of the infrastructure.

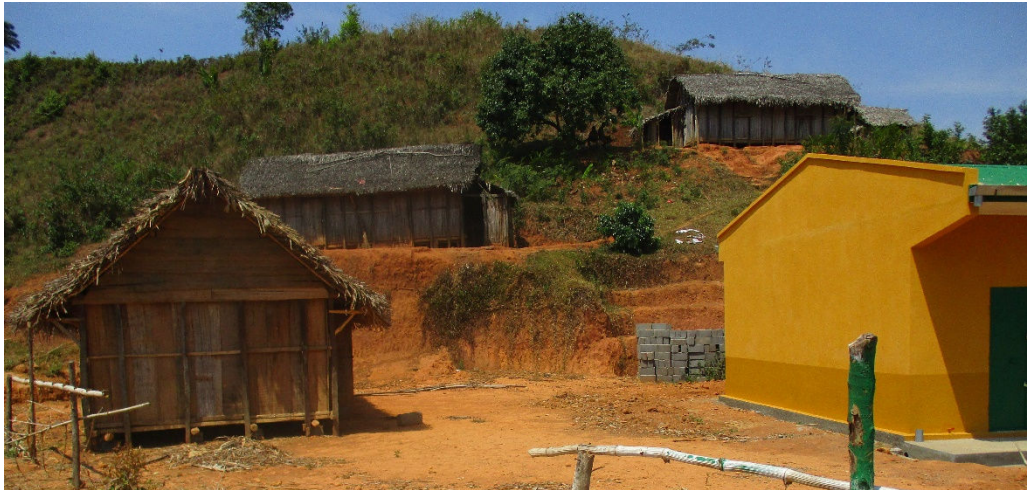
On completion of the project, the president of the parents association and the head-teacher declared that it was decided in their Annual General Meeting to recruit a caretaker/guard to ensure the security of the new school buildings. The recruitment process is already underway and the parents association has already built housing for the school caretaker / guard next to the school.

Figure 12: The housing built for the caretaker/guard (left).

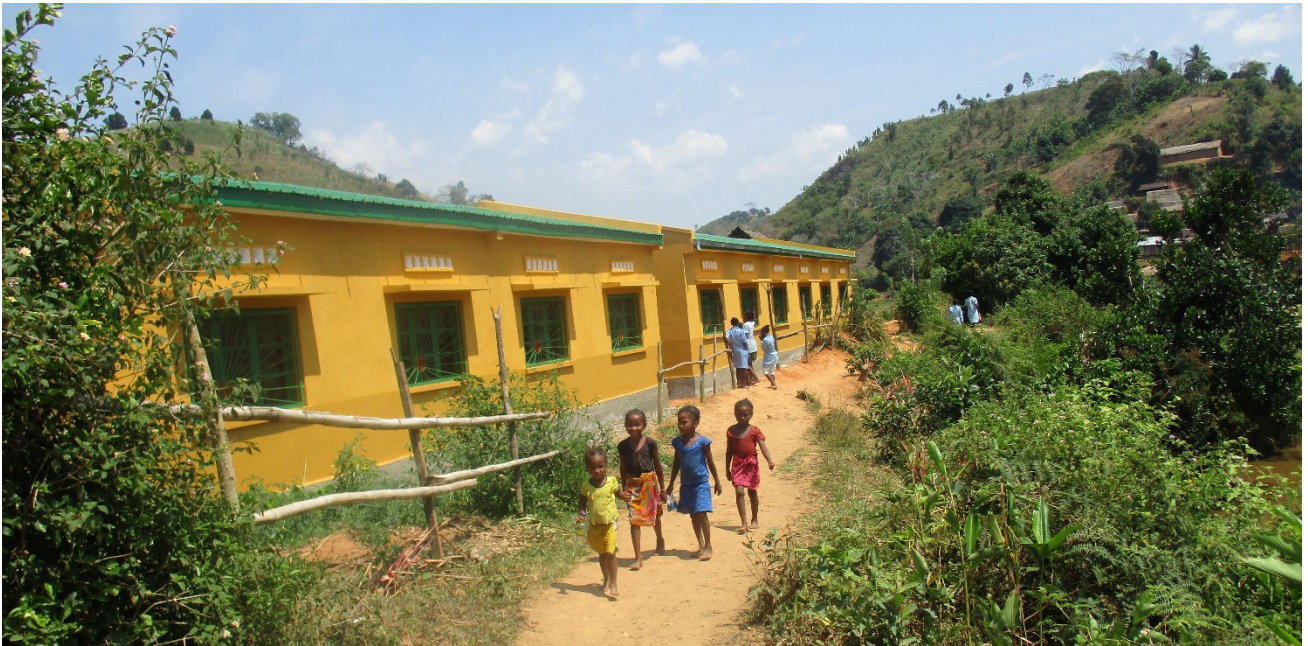
Figure 15: Front and posterior views of school buildings.

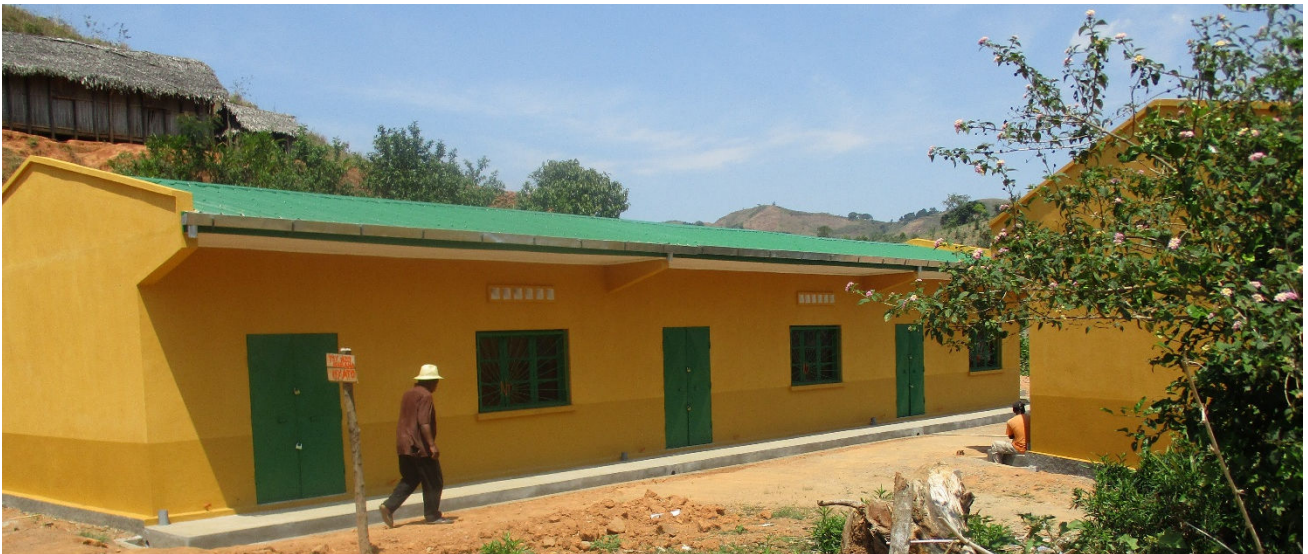
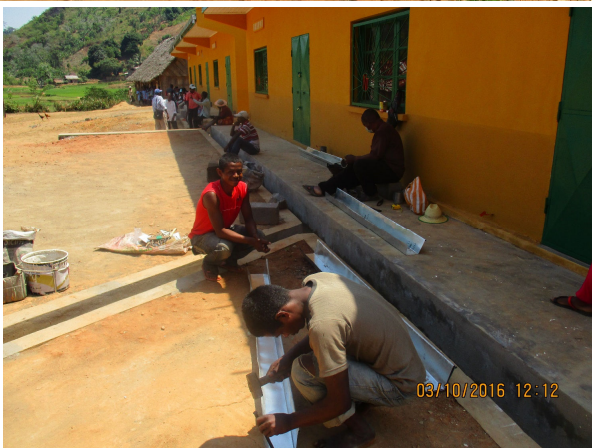
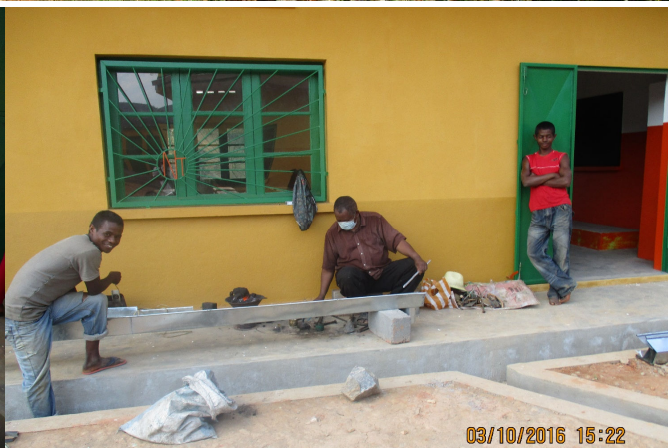
Figure 16: Installation of guttering at Tanakambana Secondary School.

For future projects, it is suggested that metal guttering is replaced by reinforced concrete guttering integrated into the building work. This is considered to be the most long-lasting, and could be cleaned periodically to avoid drains getting blocked.

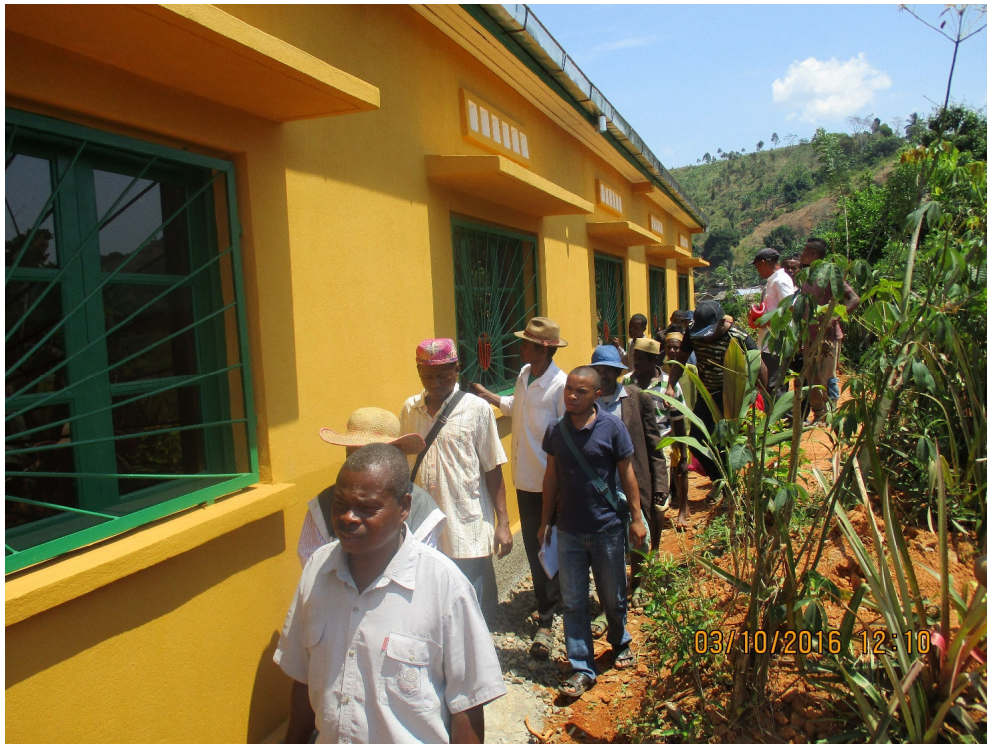
Figure 17: Participants inspecting the school before the technical acceptance of works.
