# **Construction of the Akondromainty Health Centre in Madagascar (FF 484-05)**

## **Final report**

**Feedback Madagascar/Ny Tanintsika (FBM/NT) –  
The Eagle Foundation**

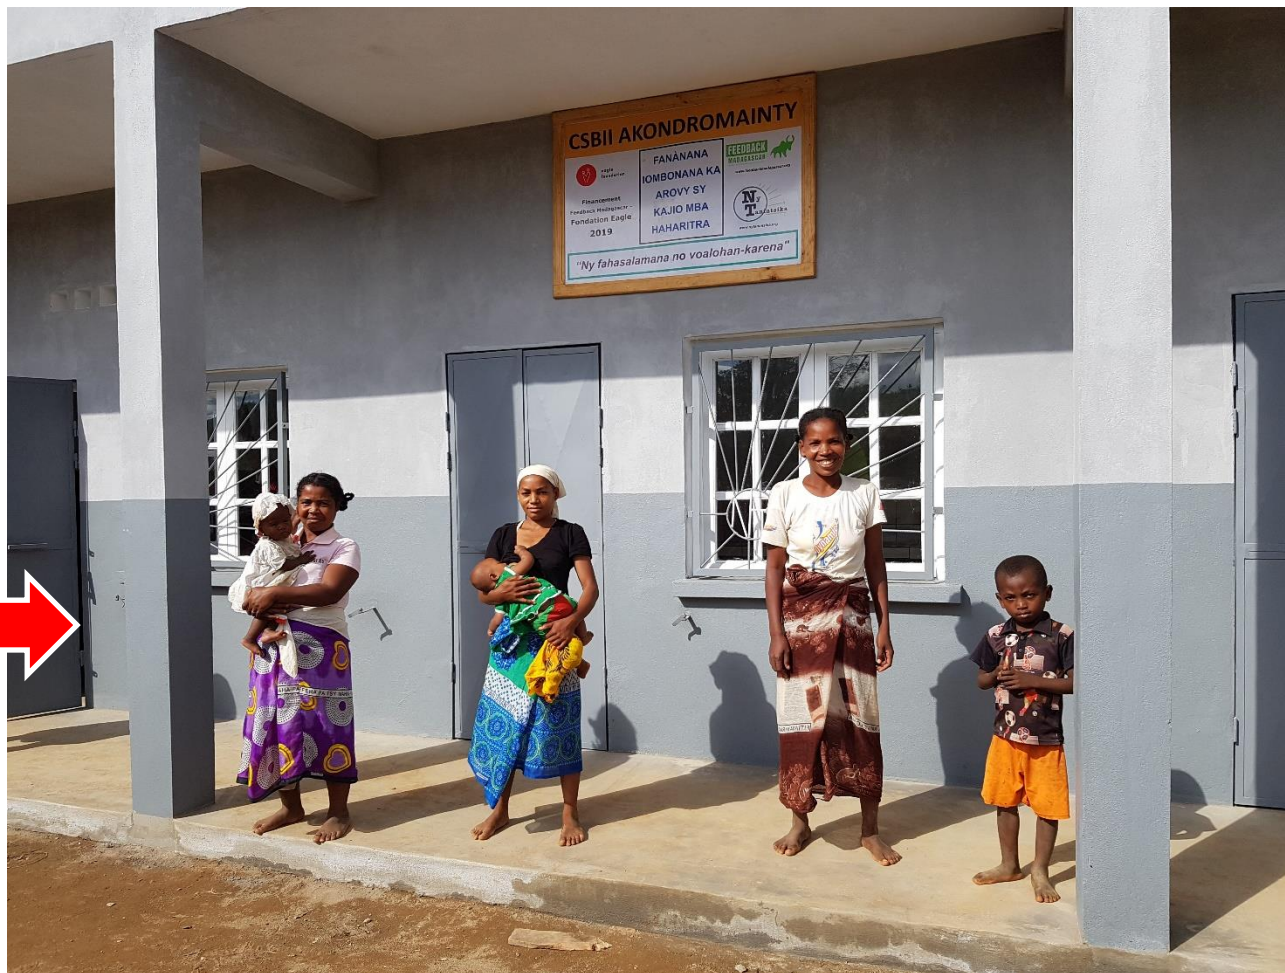
Figure 4: Akondromainty Health Centre before (left) and (right) on completion.

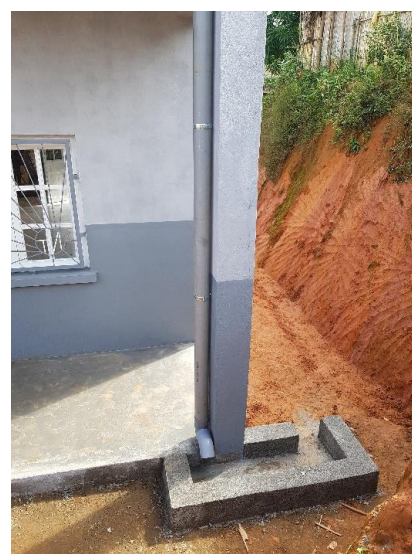
- That the community should finish certain tasks including; finishing touches to the palm roofing of one of the gazebos, digging a small ditch around the health centre to channel rainwater away, planting a lawn around the health centre (to help in-filtration of rainwater & lessen mud), planting anti-erosive vetiver plants on the slopes around the boundary of the Health Centre, improving access to the sanitation block and incinerator via steps down, and ensuring the path to the health centre allows for wheelchair access.
- That FBM-NT should re-solder some of the metal doors (due to damage caused during transport), deliver the remaining furniture/equipment (these have been achieved) and a metal ladder to access the impluvium rainwater tank.

*Figure 11: The community will be improving water evacuation channels & planting grass around the Health Centre.*

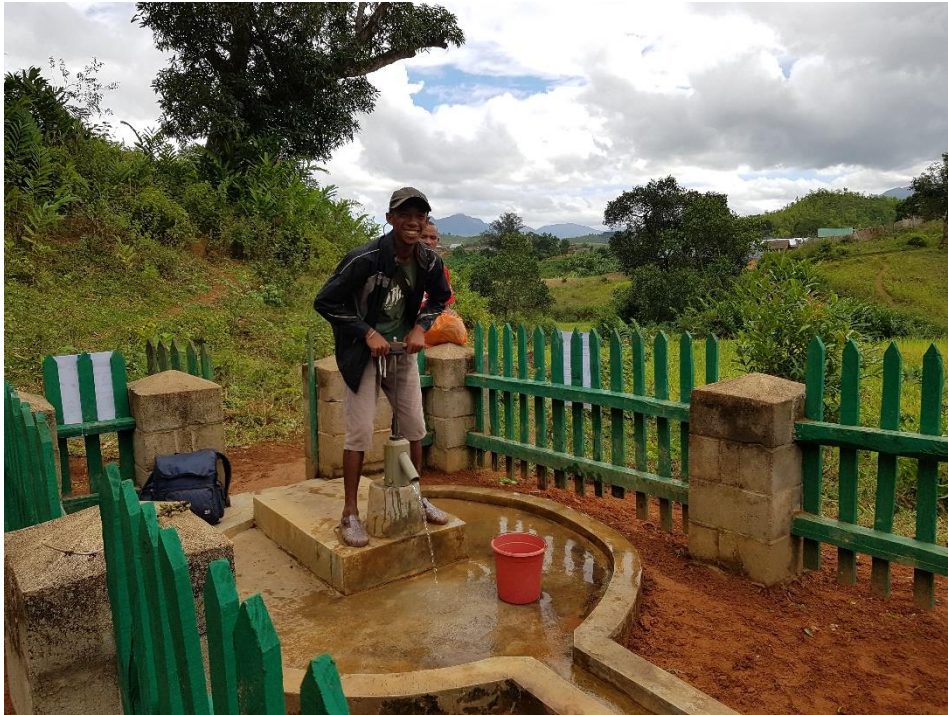
As explained in the proposal, this health centre/ village was already provided with a source of clean drinking water via the drilling of a borehole and its installation with a hand-pump in October 2018. This is still fully functional and remains the only source of potable water for the village.

*Figure 18: Akondromainty health centre & village's borehole.*

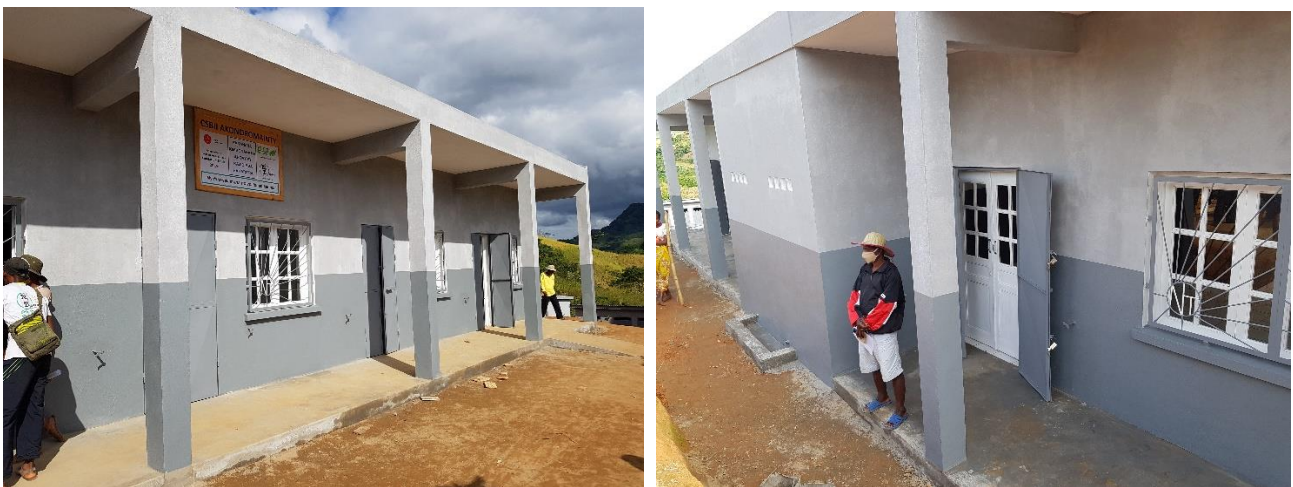
The Akondromainty Health Centre building measures 18.20m x 10.3m with a height of 4.8m (ceiling height of 3.5m). The building is made of cement breeze-blocks, dimensions 15x20x40cm.

- Verandas on two sides of the building.

*Figure 19: The front & back of the health centre.*

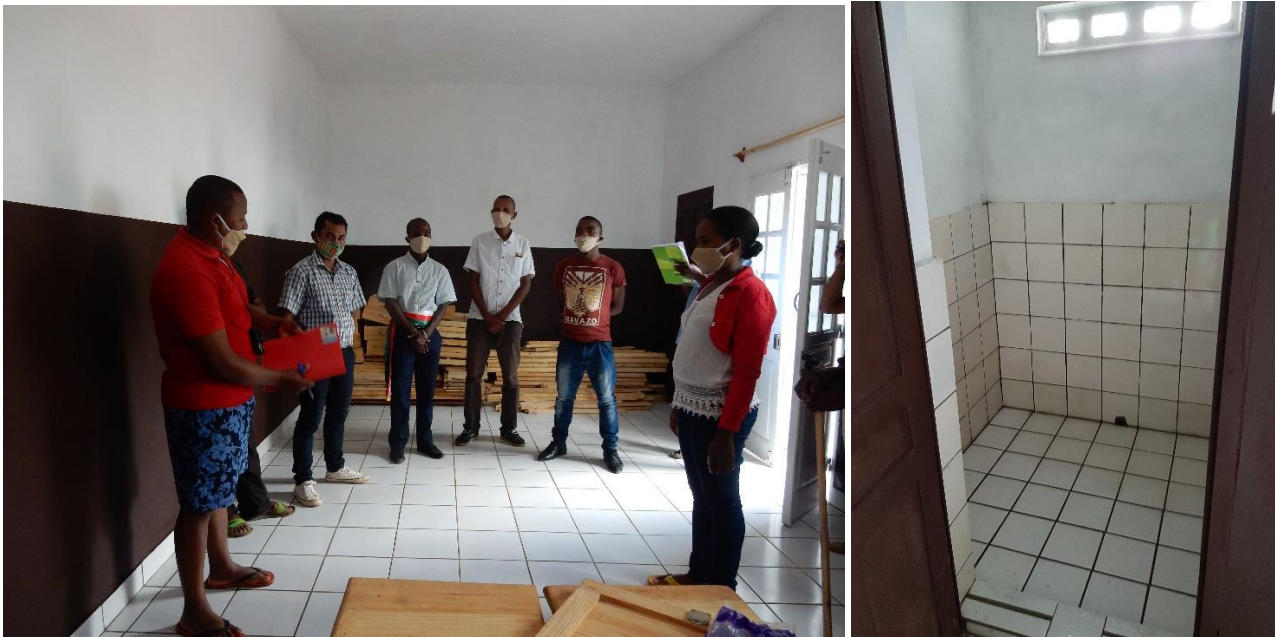
- An L-shaped hospital ward for the sick (with an attached shower), the Doctor's surgery, the midwife's consultation room, a pharmacy, a treatment room, a delivery room and a maternity ward (with an attached shower).

*Figure 20: The maternity ward & adjoining shower.*

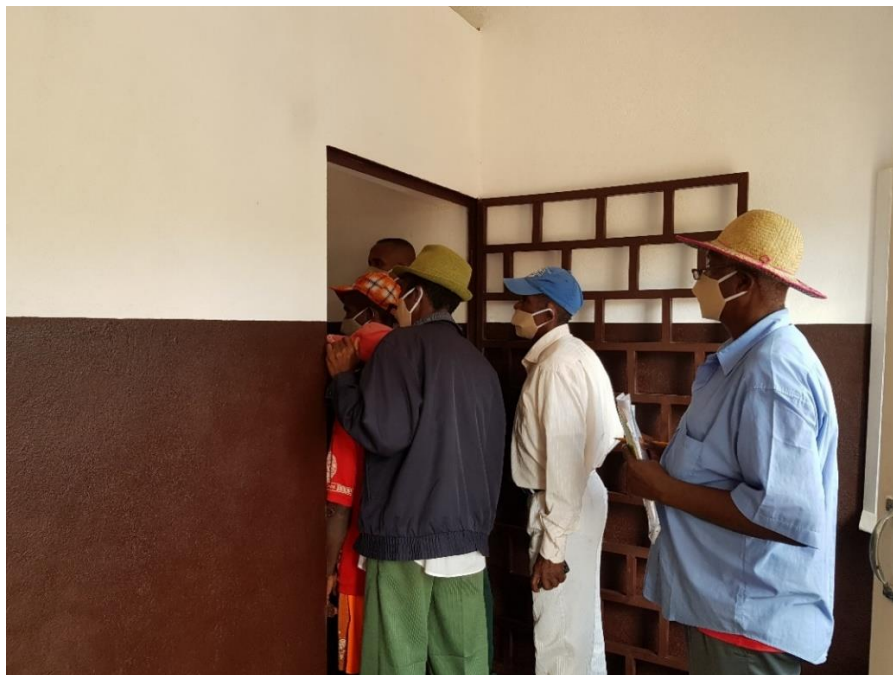
- Stone foundations and cement breezeblock walls with a reinforced concrete structure.
- Cement rendering on inside and outside walls. Cyclone-proof tin roofing.
- 7 exterior metal doors with hooks to hold them open on the outside, and glass-paned interior doors painted with white oil paint. 3 inside wooden doors between rooms, and 2 doors to the shower rooms. In addition, an additional protective door grid between the storeroom and the dispensary.

*Figure 21: The protective door grid between the storeroom & the dispensary.*

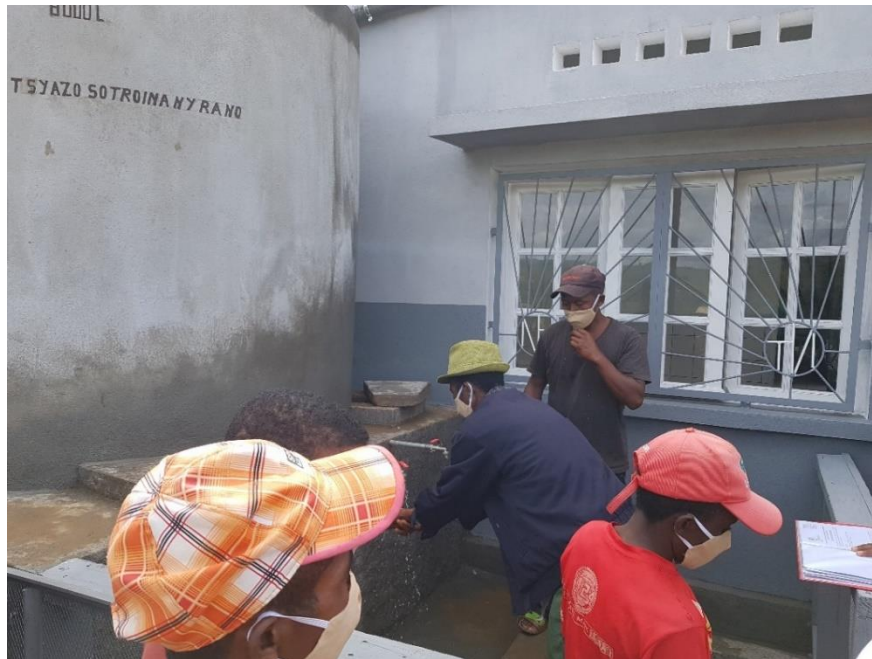
- A total of 10 windows. Windows with glass panes, opening to the inside with metal security bars on the outside.
- Front and back guttering (integrated into the building design) with 4 down-pipes, and linking to a 8m<sup>3</sup> water tank serving as a hand-washing station to the right side of the building between the toilets and the health centre to promote hand-washing at key moments. This is connected to 3 taps. This integrates a system to prevent the first rains (which brings the dirt from the roof) from entering the tank. The tank is located on the side between the toilets and the health centre to promote hand-washing at key moments. The tank is equipped with a locked manhole cover on the top to enable cleaning / maintenance as well as filling by hand during the dry season.

*Figure 22: The impluvium water tank & hand-washing station.*

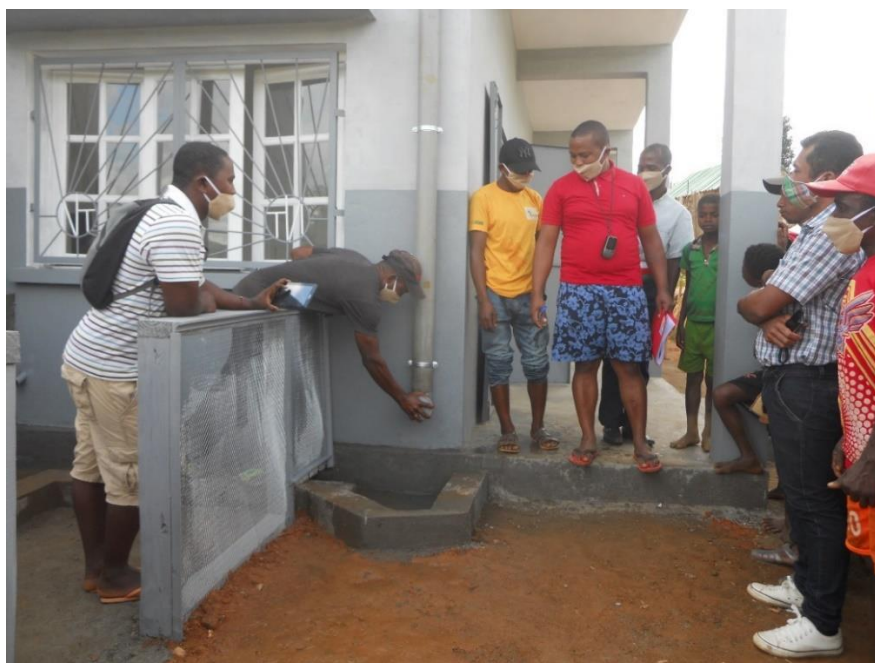
*Figure 23: The down-pipe 'disaffection' system to prevent the first rains (which bring dirt from the roof) from entering the water tank.*

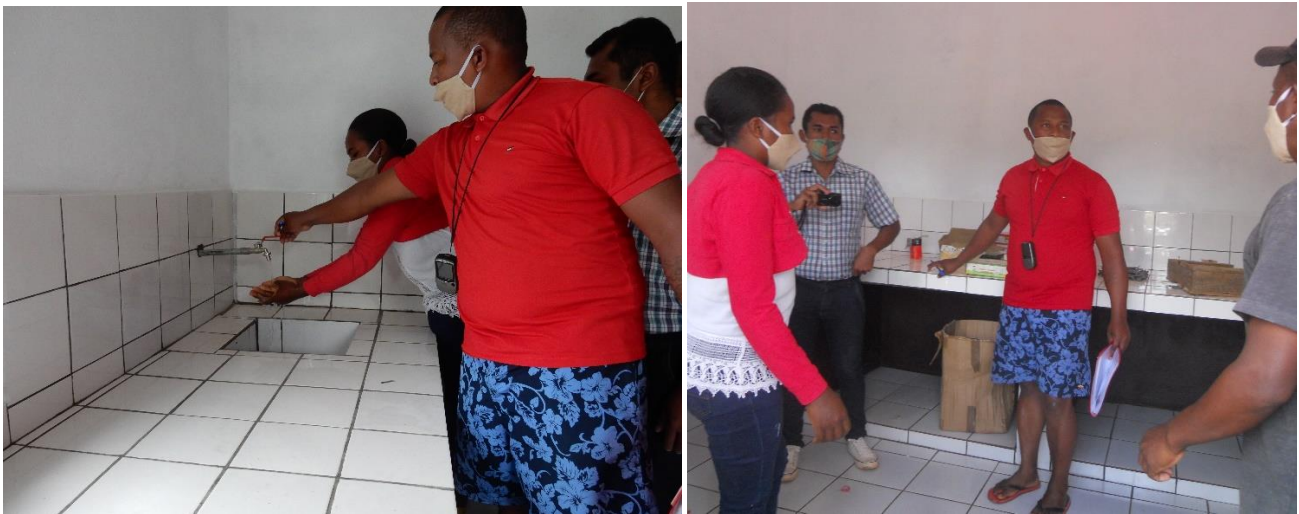
- Installation of a sink in the delivery room, linked to the rainwater catchment tank.

*Figure 24: Sink in the delivery room.*

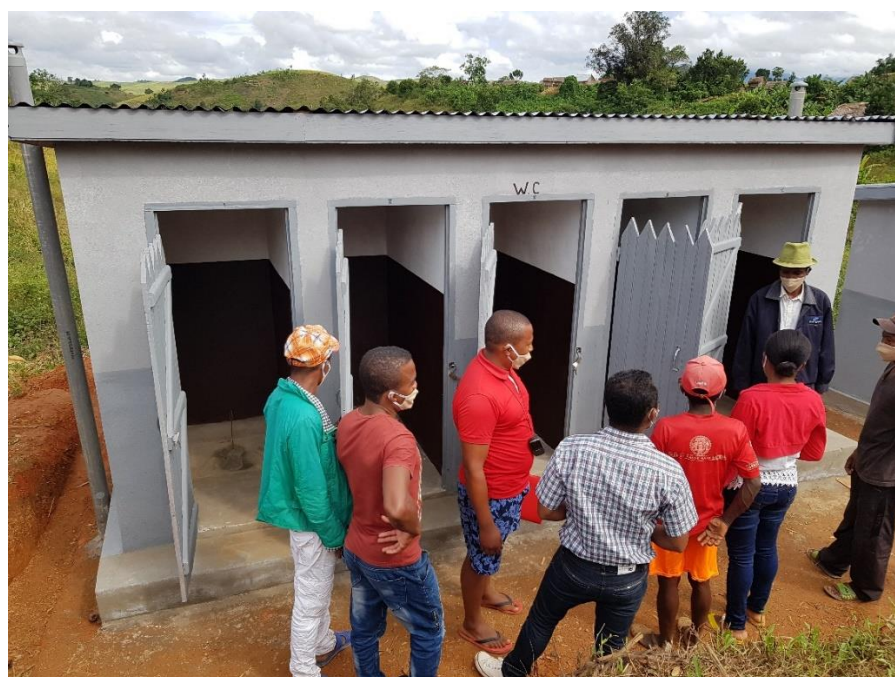
- Two-tone colouring (interior and exterior); for the exterior: dark grey oil paint at the base aligned to the lower part of the window (to protect from dirt) and water-based light grey exterior water paint higher-up. For the interior, two-tone oil paint; dark brown to a height of 1.5 metres, then white water paint to the ceiling. Cement ceilings painted with oil paint.
- Laying of floor tiles for all the rooms apart from the dispensary and the medicine storeroom, which have concrete flooring. Tiling is particularly important for hygiene in the delivery room and the treatment room.
- An outdoor sanitation block comprising five fly-proof, washable toilet compartments (1 for the sick ward, 1 for the maternity ward, 2 for outpatient use and 1 for health centre workers), with urinals on the posterior side.

*Figure 25: The external sanitation block (5 toilet compartments).*

Evacuation of urine from the urinal into the latrine pit, with an inclined urinal slab. Existence of ventilation and luminosity on both sides of the sanitary block. Installation of a pipe (PVC 60) from the pit to the top of the roof to reduce odour. The block was painted the same colour combination as the main health centre building. Eucalyptus wood door with aeration and luminosity space at the top, with single bolt inside and padlock on the outside door.

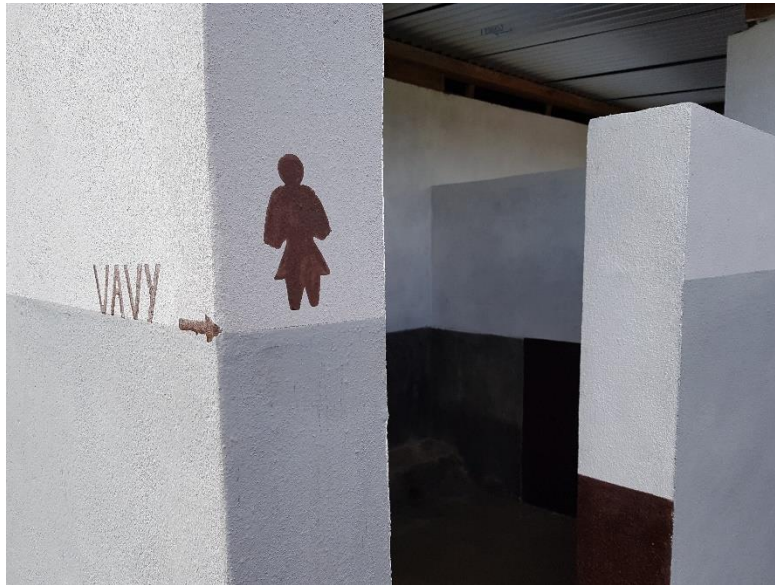
- Sheet metal roof covering the urinals (to prevent rain water from entering the pit). Indication for male and female urinals.

*Figure 26: The female urinal.*

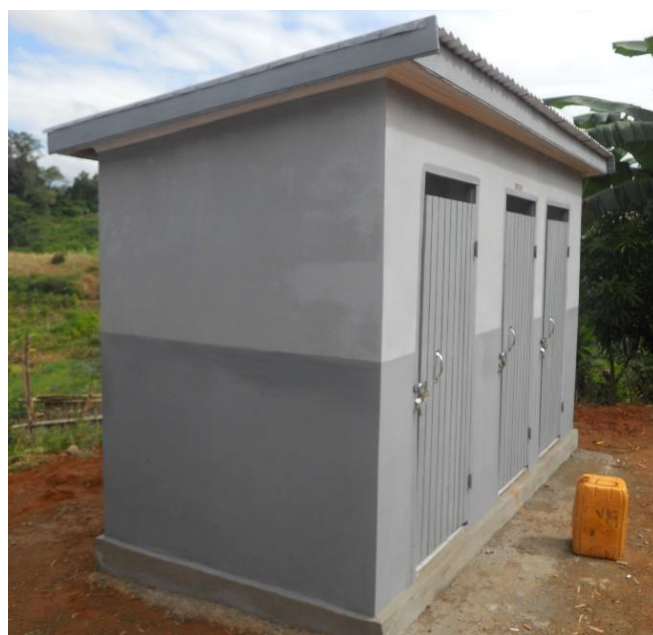
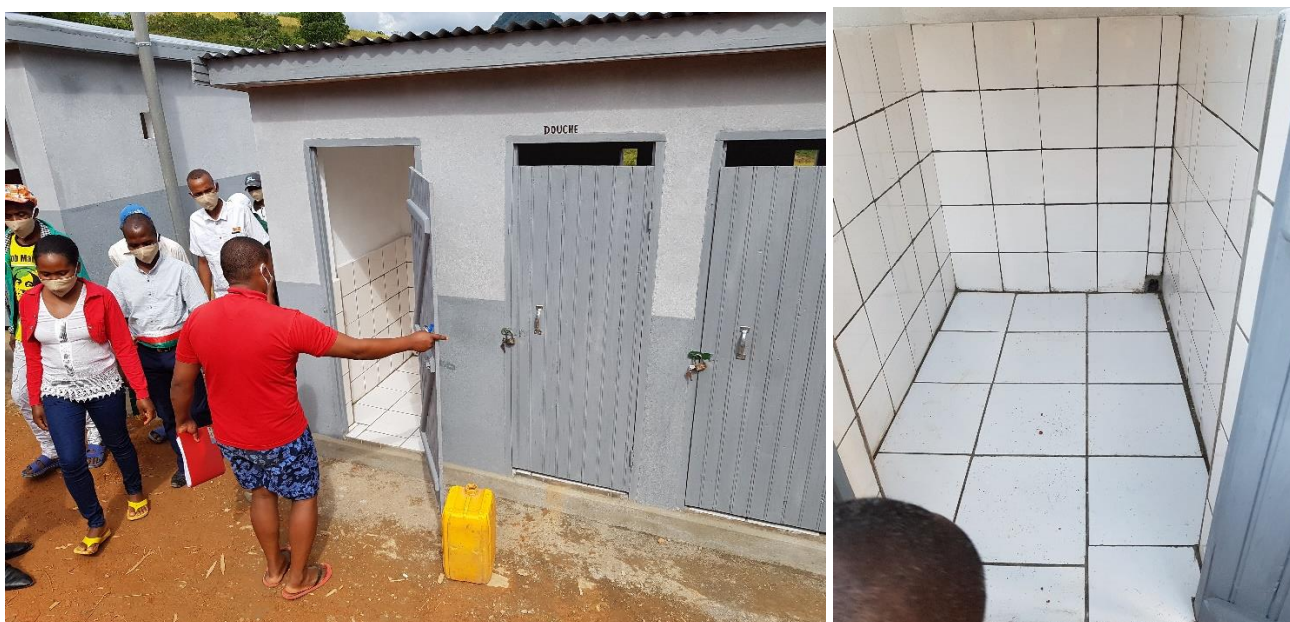
- 3 outdoor shower cubicles for bucket-showers, laid with tiles and with water outlet and ventilation at the rear. Corrugated iron roof and eucalyptus wood door with aeration and luminosity space at the top, with single bolt inside and padlock door outside. The showers were painted the same colour combination as the building.

*Figure 27: The outdoor shower block.*

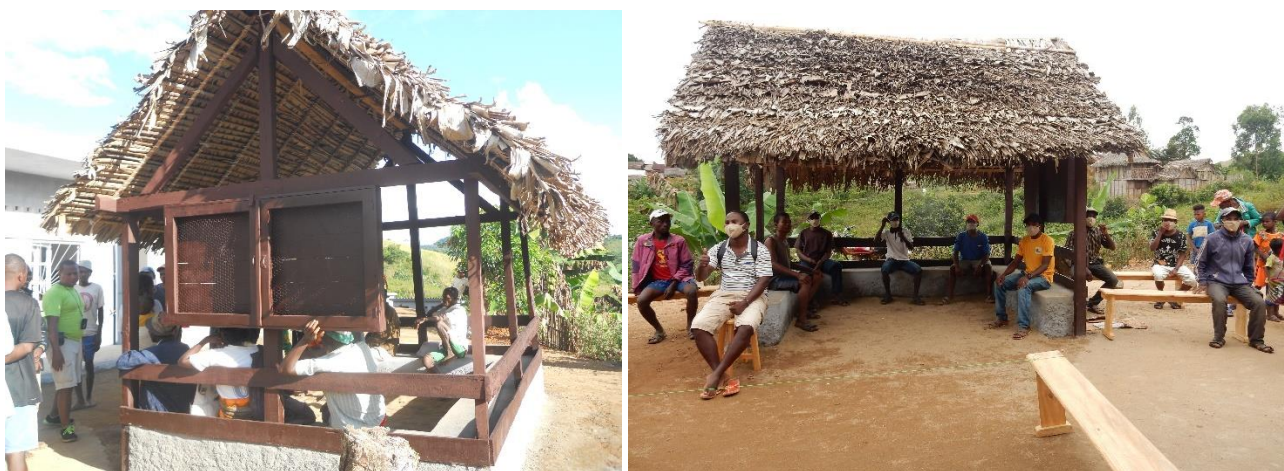
- 2 gazebos were built to be used as waiting rooms or sheltered rest spots outside the health centre. These were made of local materials: « Ravinala » travellers' palm leaf roof (provided by the local community), eucalyptus wood frame and a concrete bench on 3 sides.

Figure 29: Gazebo design next to the health centre.

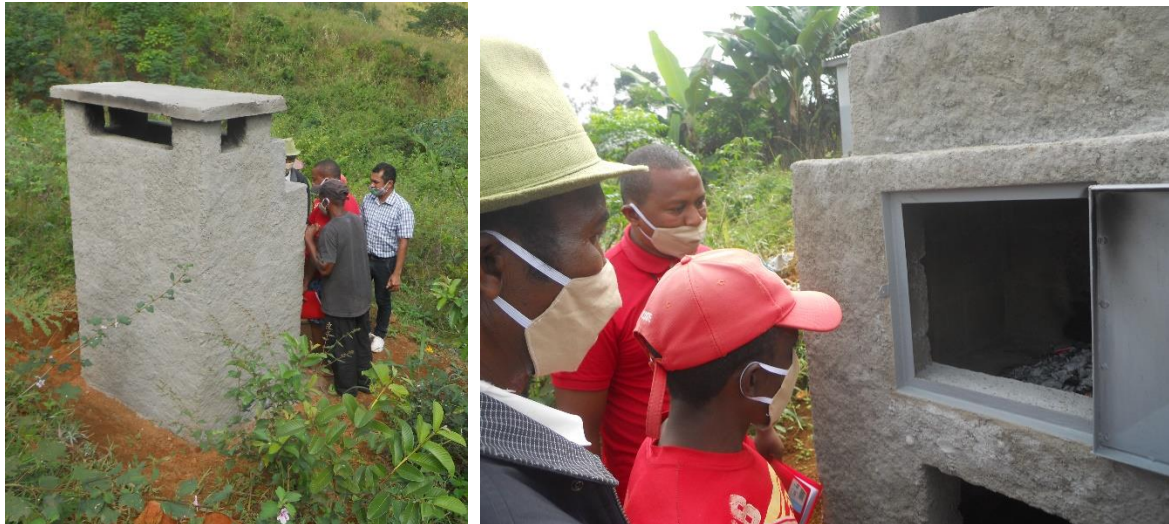
- A sign was placed outside the building with the name of the Akondromainty Health Centre, the name of the donor and partners, and two awareness-raising messages: « *Fanana iombonana ka arovy sy kajio mba haharitra* » (Look after communal property so that it lasts a long time) and « *Ny fahasalamana no voalohan-karena* » ("Health is the greatest wealth").
- An incinerator was built below the sanitation block to dispose of health centre waste in a safe manner.

*Figure 30: Health centre incinerator for safe waste disposal.*

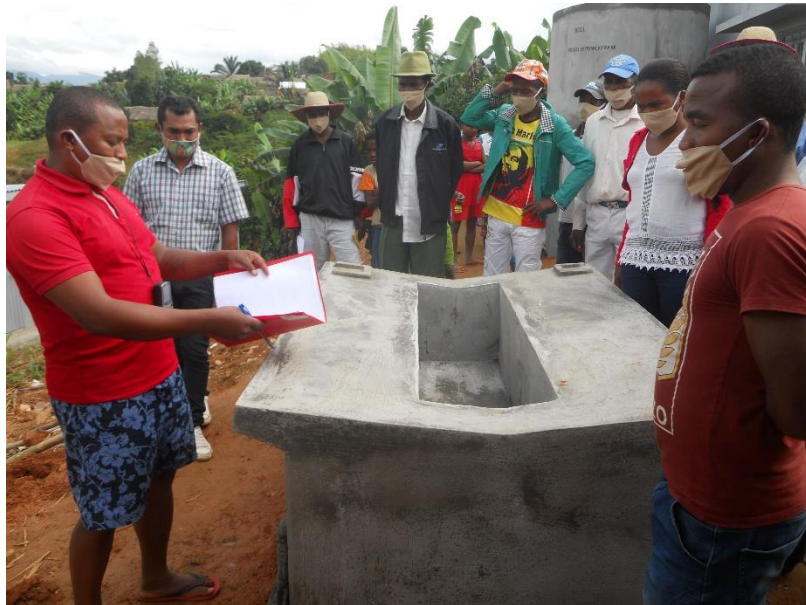
- An outdoor washbasin for clothes washing was built on the request of beneficiaries.

*Figure 31: Washbasin outside the health centre.*
