Osiligi Charity Projects

Repair of broken hand pumps in Kenya FF 0504-25

2020 Interim Report

For the Eagle Foundation
Covering pump repairs during Jan - May 2020

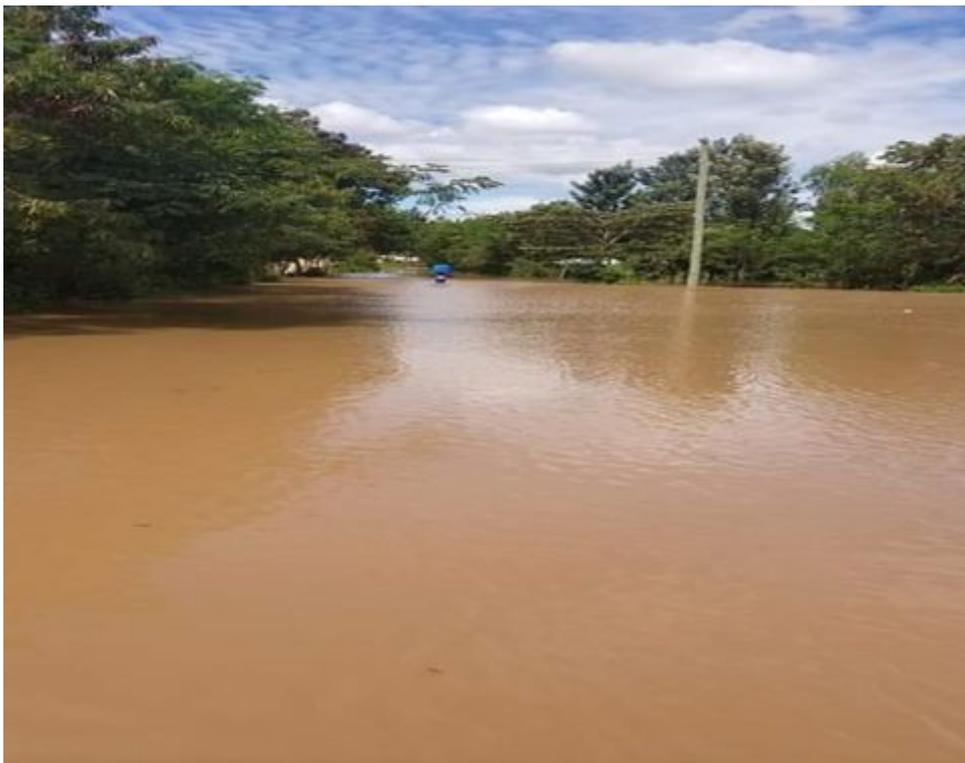
Transportation didn't get any easier.

Flooding makes it dangerous to even consider travelling to a rural location. Adding to the delay in the repair. Another consequence of the flooding is in the pollution and contamination of the area around a borehole or well.

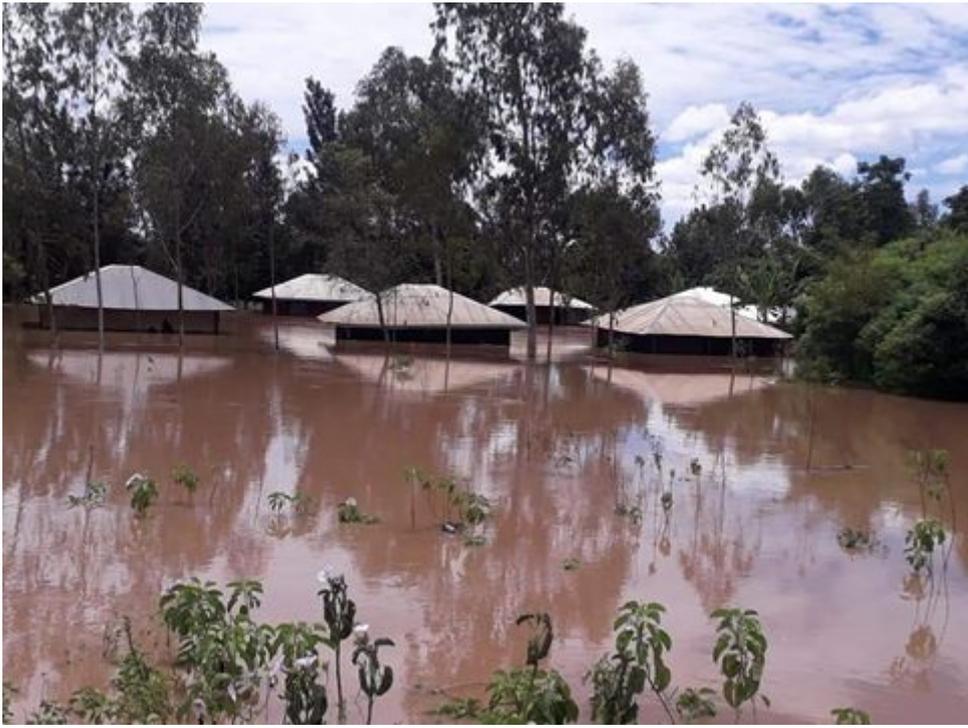
Homes with running water.

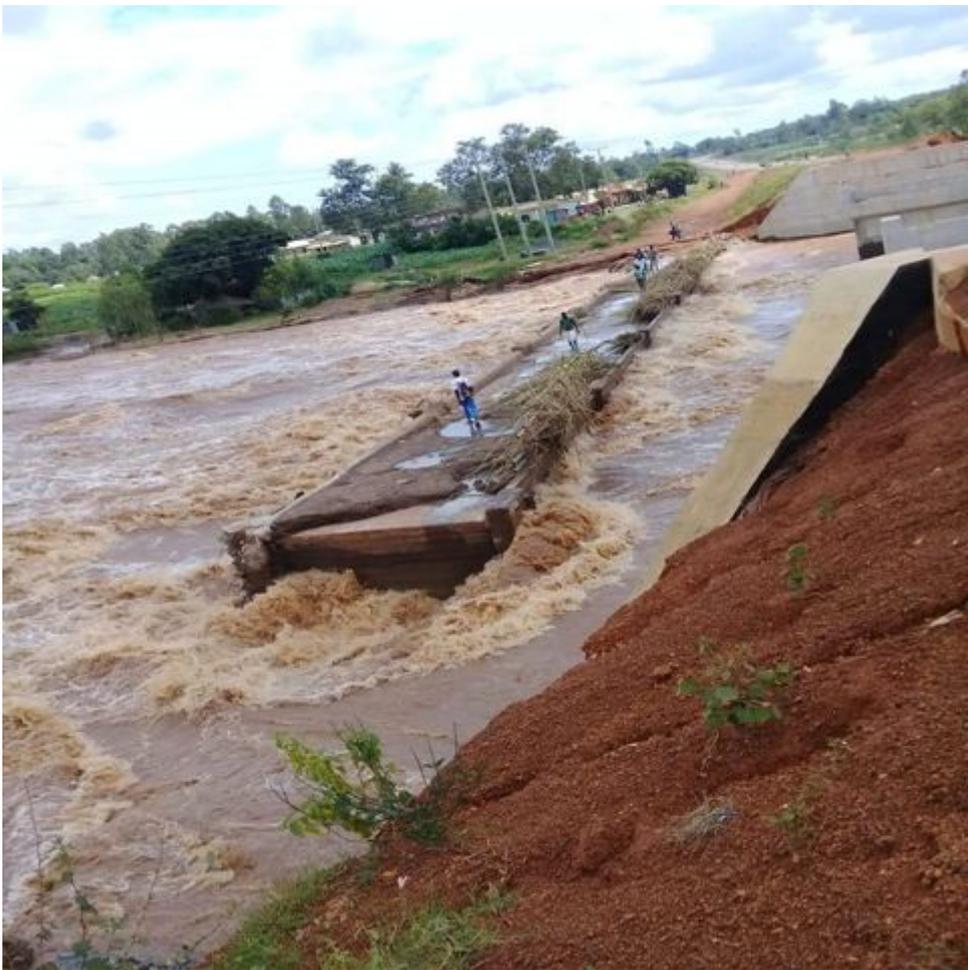
Nzoia bridge now NOT linking Alego to Ugenya in West Kenya

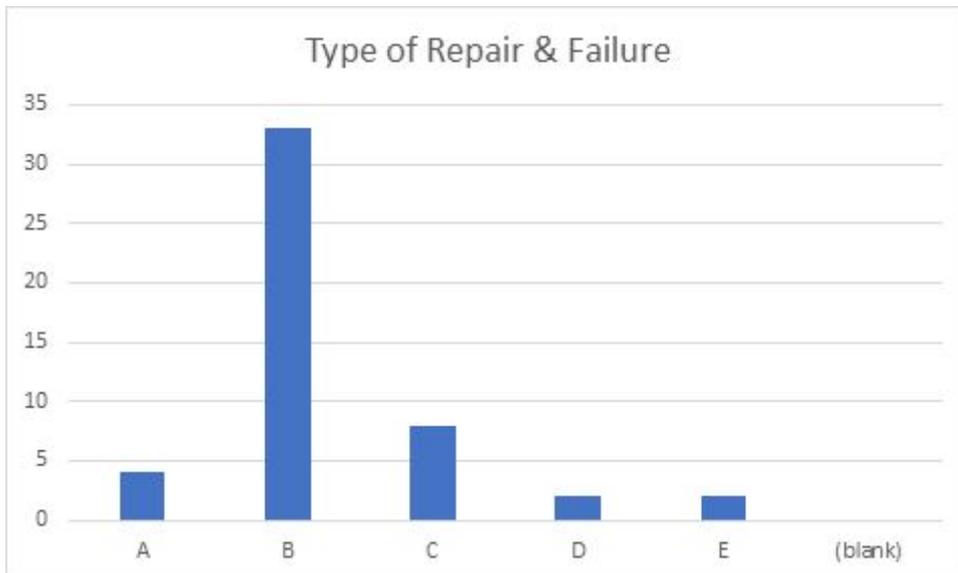
We have analysed the cost of repairing 47 of the 59 repaired pumps and this is shown below. The analysis is of the direct material costs only and excludes the indirect costs of transport, accommodation, meals etc. In the far away rural areas, the indirect costs can considerably add to the direct material costs, especially during the covid-19 outbreak. The direct costs are split into 5 categories, A to E. A (4 pumps) is a simple repair where the parts cost less than 5,000Ksh (£40). B (33 pumps) is a more extensive repair where more parts are needed at a cost of between 5000Ksh and 25,000Ksh. All of A repairs and many of B repairs could have been done by the community themselves after suitable training.

Category C (8 pumps) is a more extensive repair where the risers and rods had to be removed. These repairs cost between 25,000 - 50,000Ksh and are usually due to a broken pump being left unused for a long time, a pump that has been vandalised or a pump that has worn out due to heavy usage. D (2 pumps) is the installation of new pumps as the old one's were beyond economic repair. Finally, E (2 pumps) need a more extensive repair, such as having to employ a contractor to fish out broken pipes from the bore-hole, or to flush the bore-hole because it was blocked. Usually a new pump is required. Any old parts, if possible, are recycled.

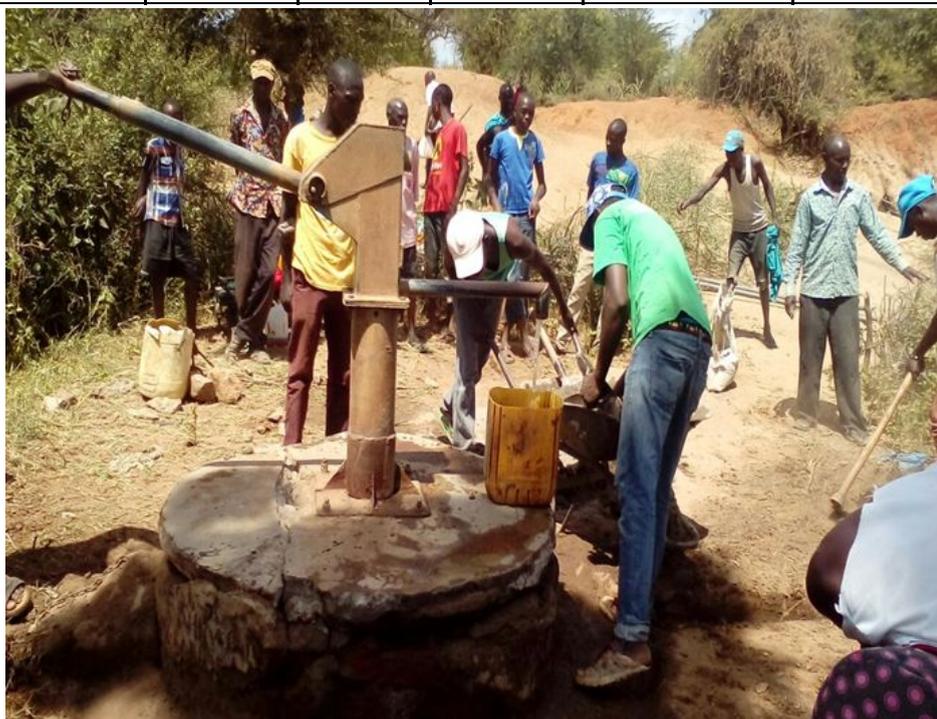
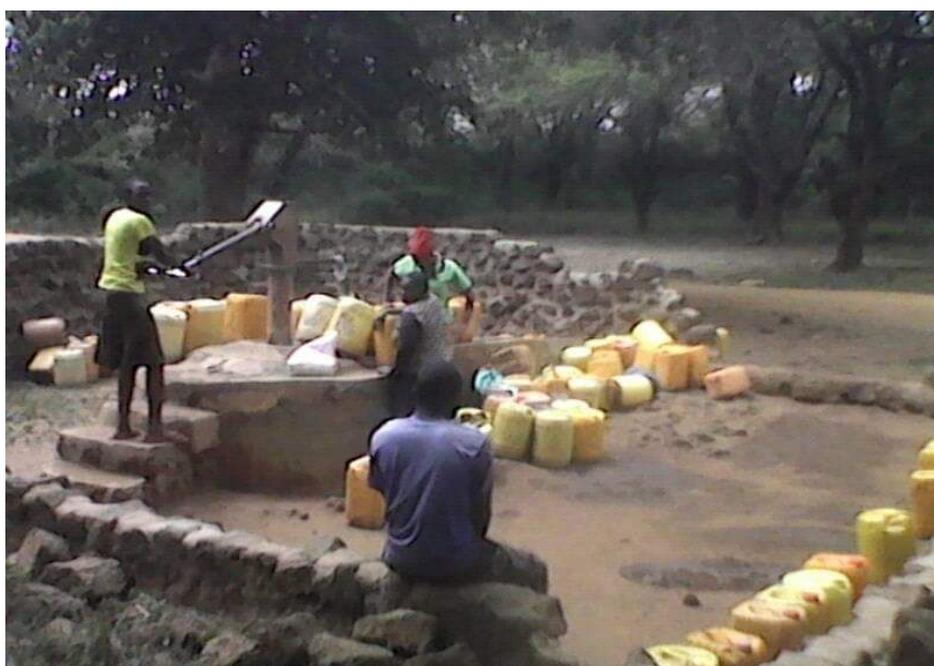
Ikanga and Mutito community wells

PUMP NAME	COUNTY	PUMP TYPE	PEOPLE SERVED	G.p.s coordinates	WELL PARAMETERS	TYPE OF REPAIR	STATUS
Ikanga	Kitui	Afridev	300	1.7256 S,38.0764 E	12 Feet of water 27 feet deep	Replaced 2 rising pipes and bent rods	working
Mutitu	Kitui	Afridev	200	1.2250 S 38.1887 E	10 feet of water 25 feet deep	2 Broken risers patched up	working
