Osiligi Charity Projects

Repair of broken hand pumps in Kenya FF 0559-44

2021 Interim Report

For the Eagle Foundation
Covering pump repairs during Jan - April 2021

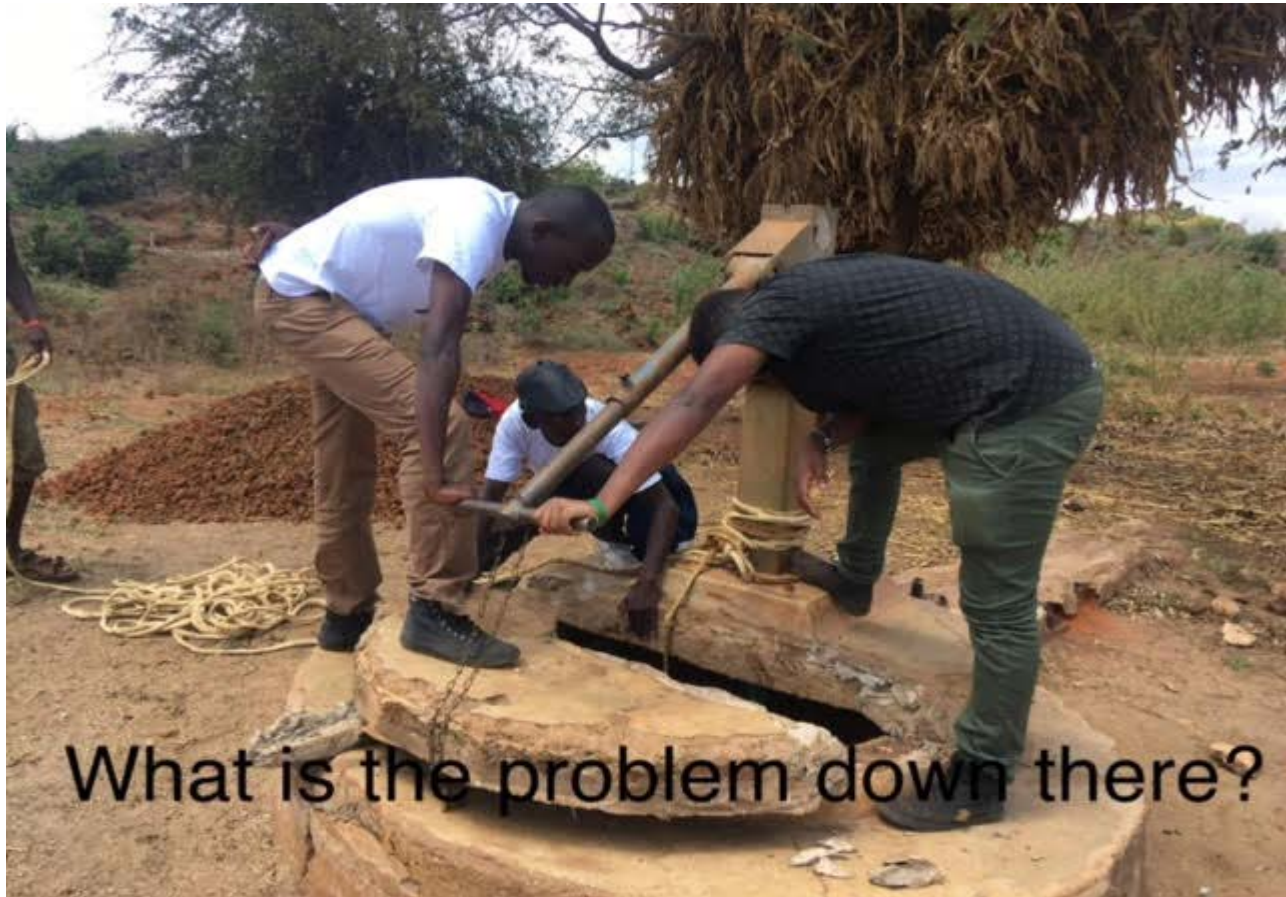
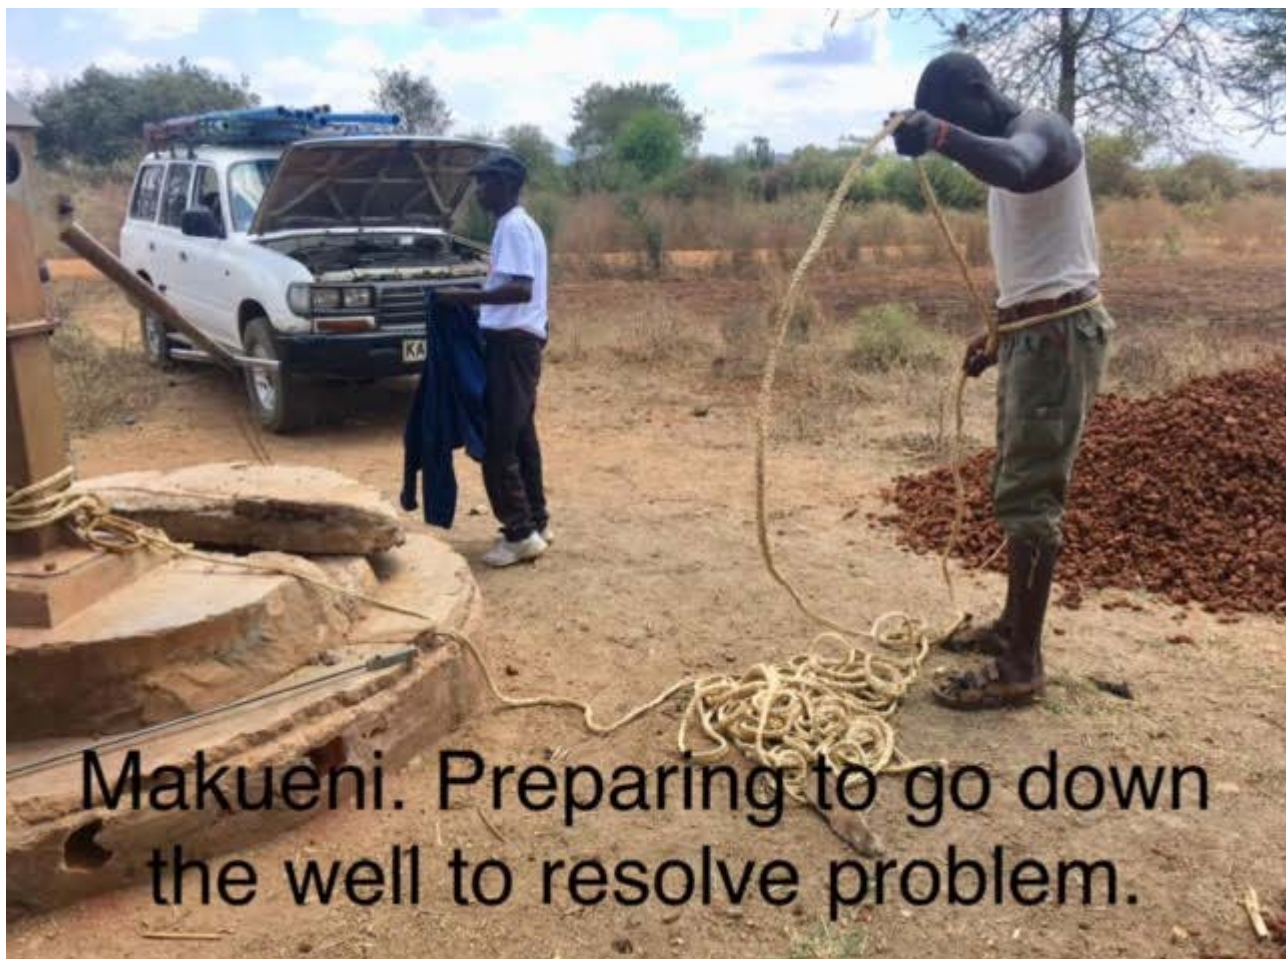
Preparing for a visual inspection

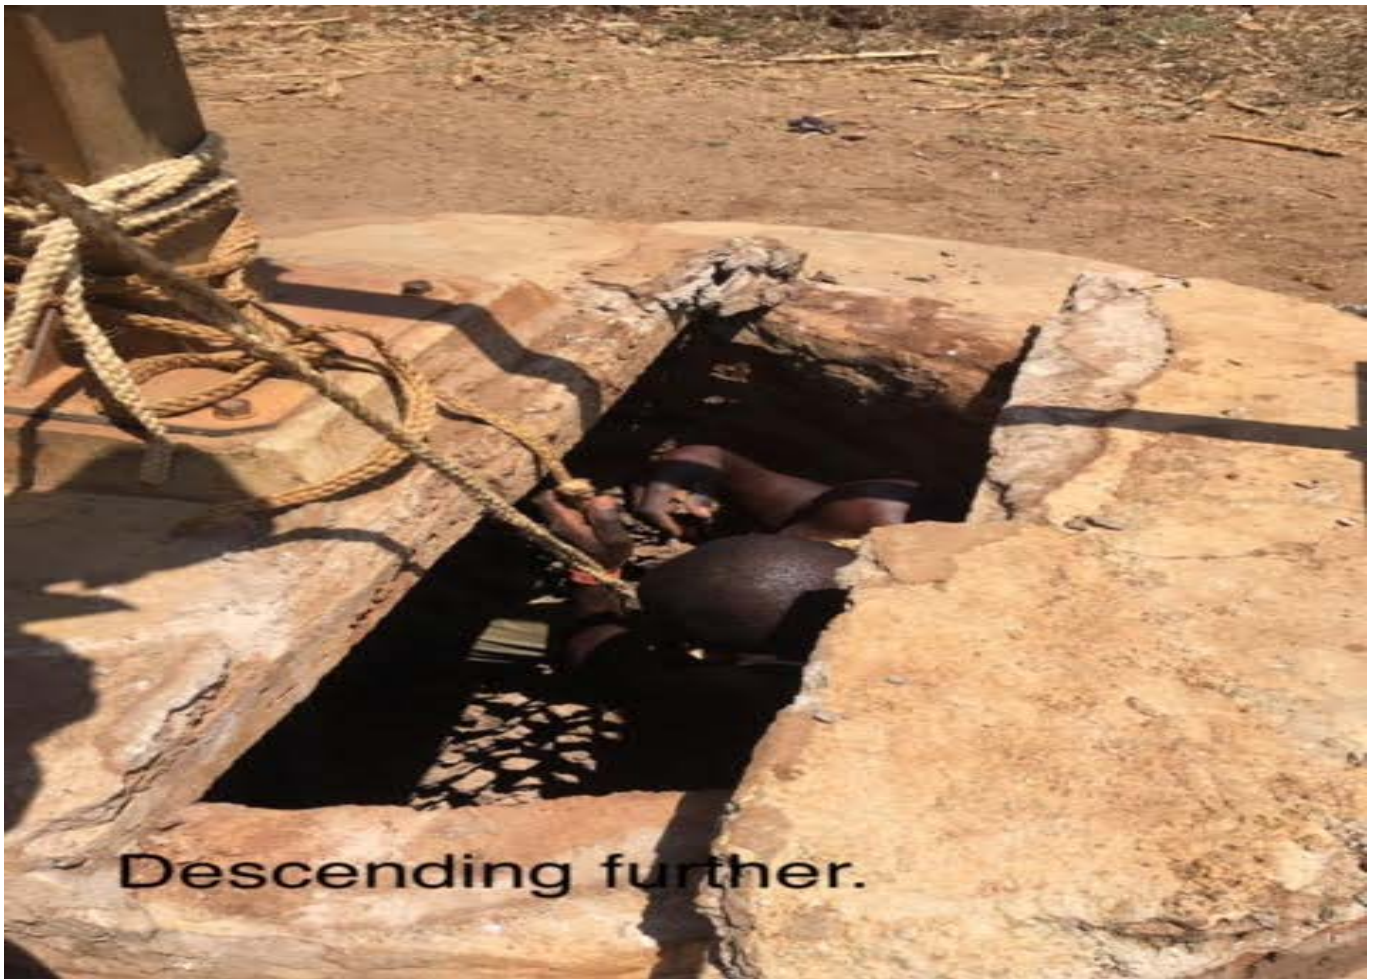
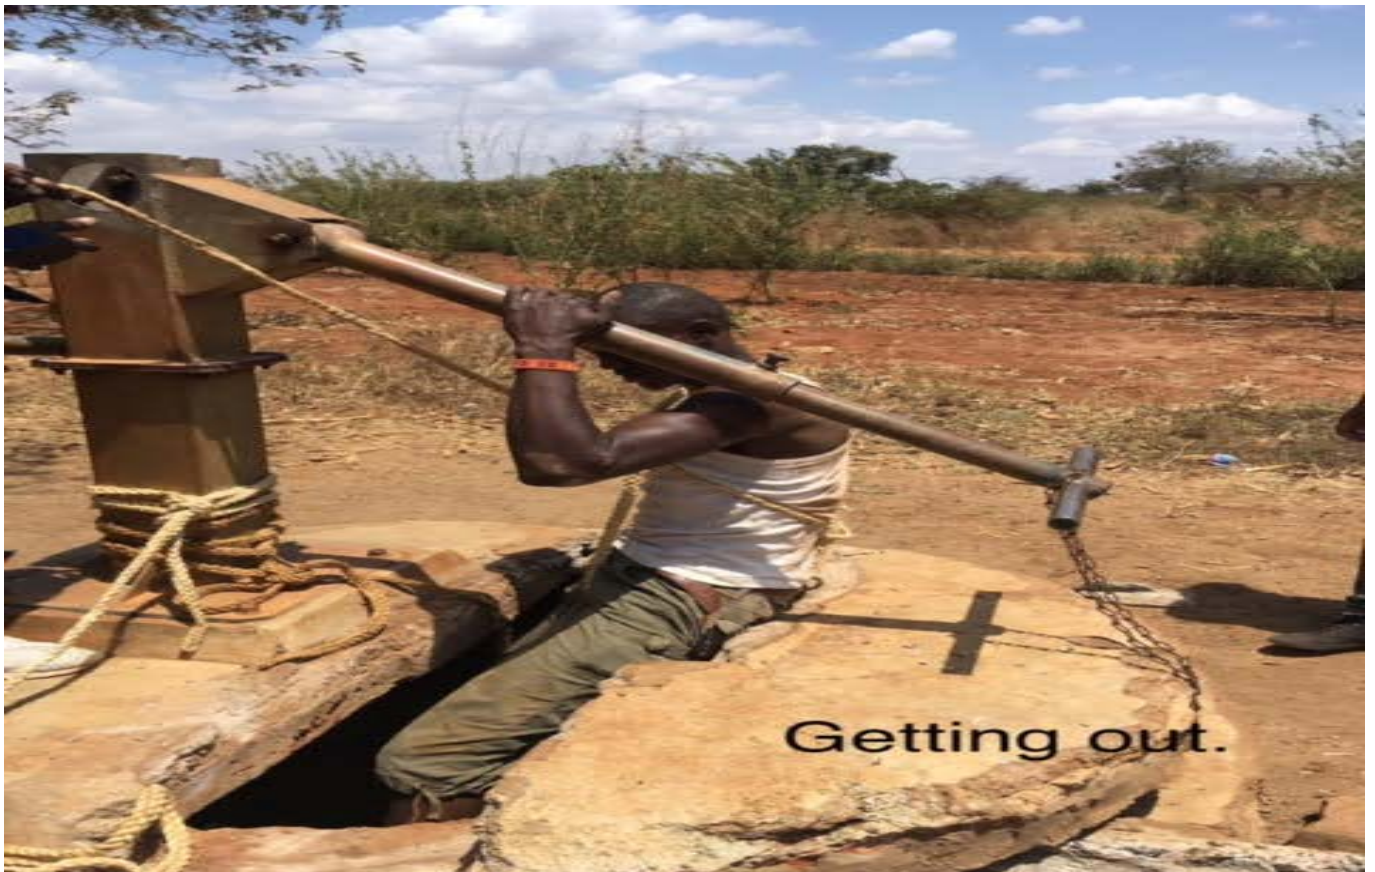
A common fault, the foot valve not working.

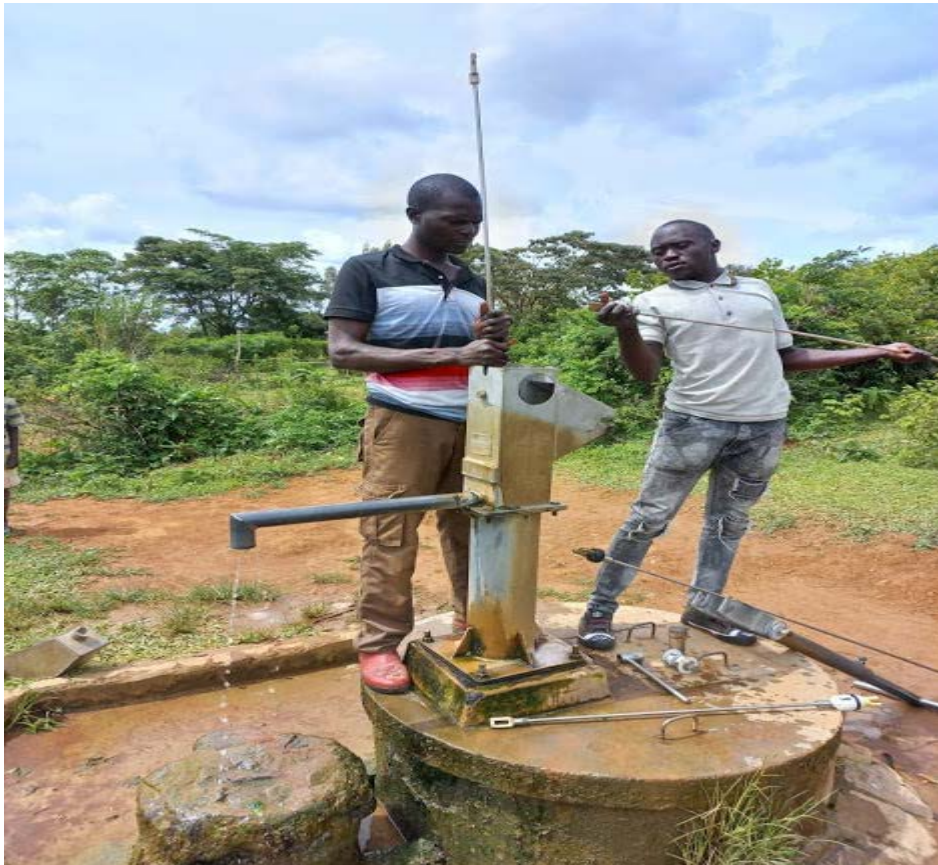
And the reason why!

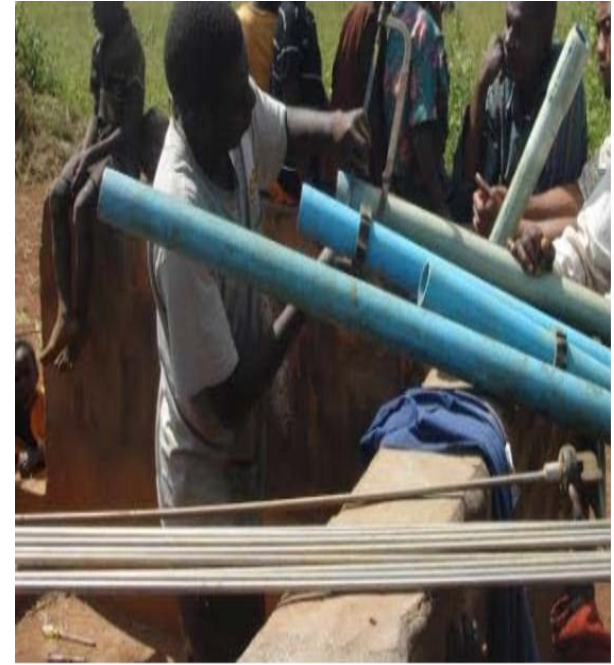
Manyula pump during repair

MUNYULA PUMP	Afridev	300	2°26'28"S 36°57'10"E	30M well depth 8M water column	cleaned cylinder, replaced bearings, hangrod, useal and centralizers	working
OSENAI PUMP	Afridev	150	2°20'32"S 37°28'33"E	25M well depth 10M water column	Replaced, useal, bobbins, hangrod, rusty rods, bearings, 3 pipes and rod centralizers	working
OLEPOLOS PUMP	Afridev	220	2°29'39"S 36°49'09"E	33M well depth 7M water column	Replaced broken foot valve, bearings bobbins, two bent rods and cleaned cylinder	working
ROMBO PUMP	Afridev	250	2°36'28" S 37°38'32"E	36M well depth 5.8 M water column	Pump concrete base was repaired, bearings and seal replaced and cylinder cleaned.	working

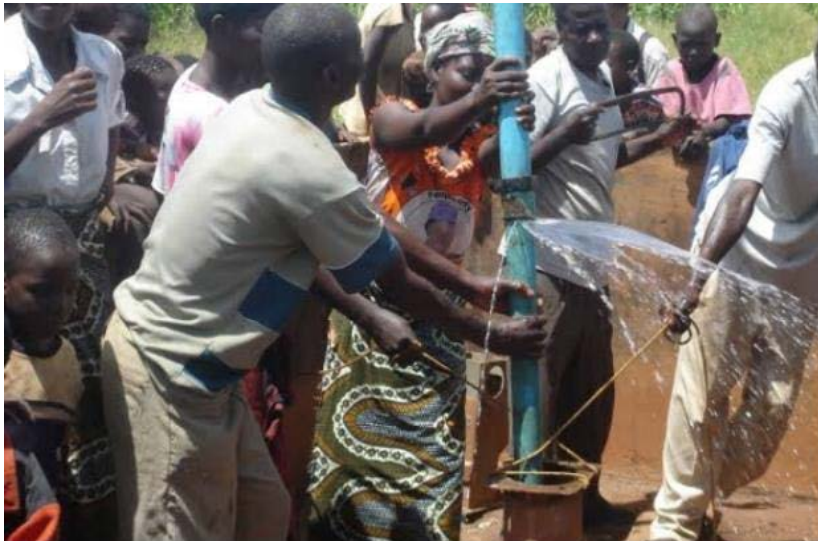
Osenai Pump. Pulling out of risers to repair a leaking pipe.

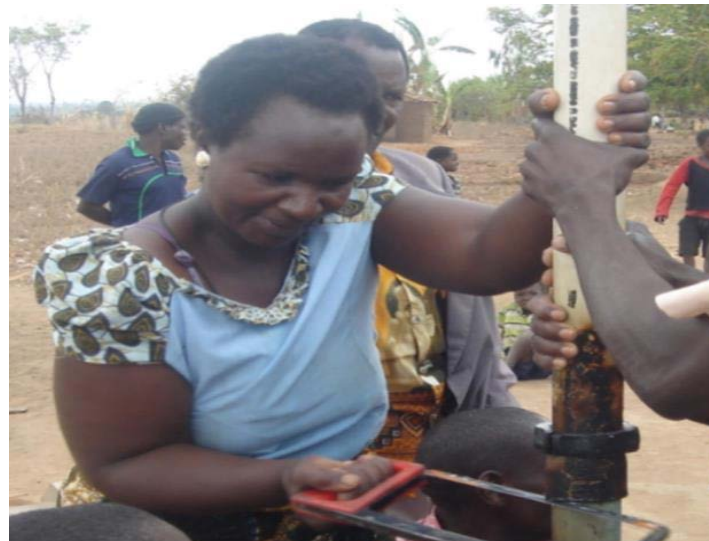
Olepolos Pump. Picture showing a woman being trained as the cylinder was pulled out for repair.

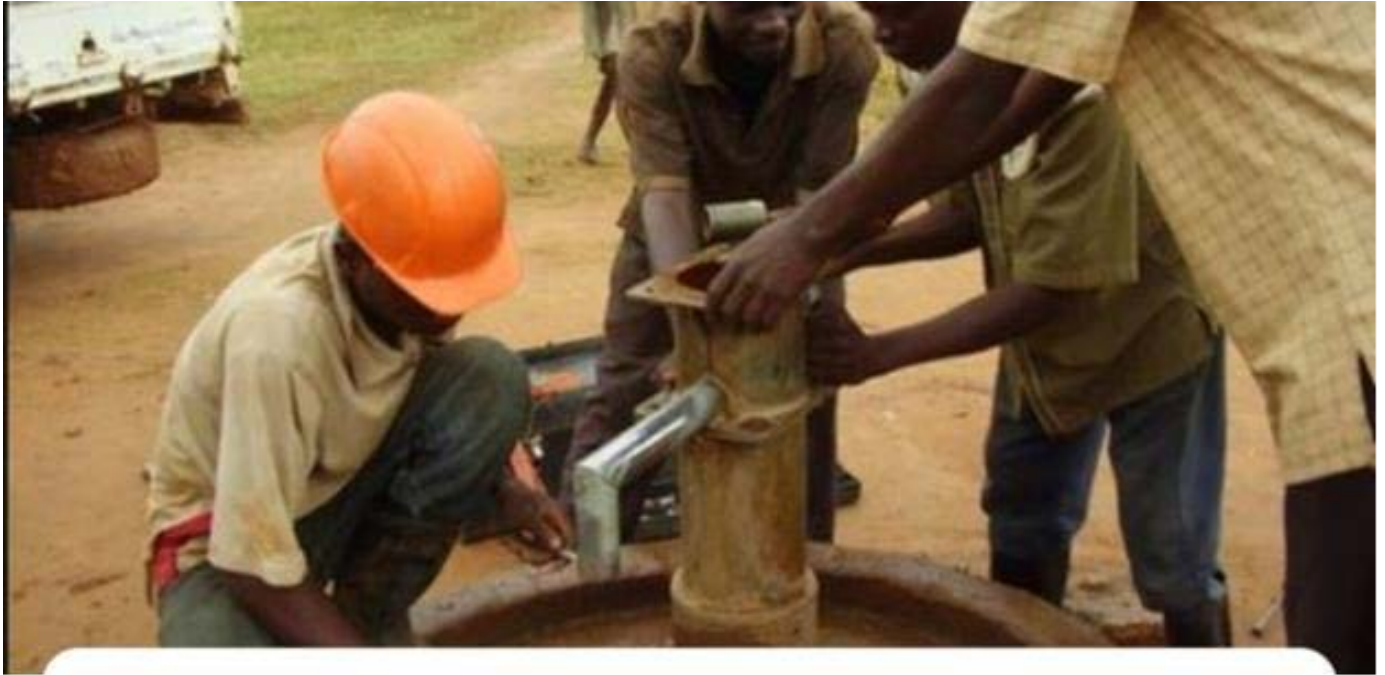
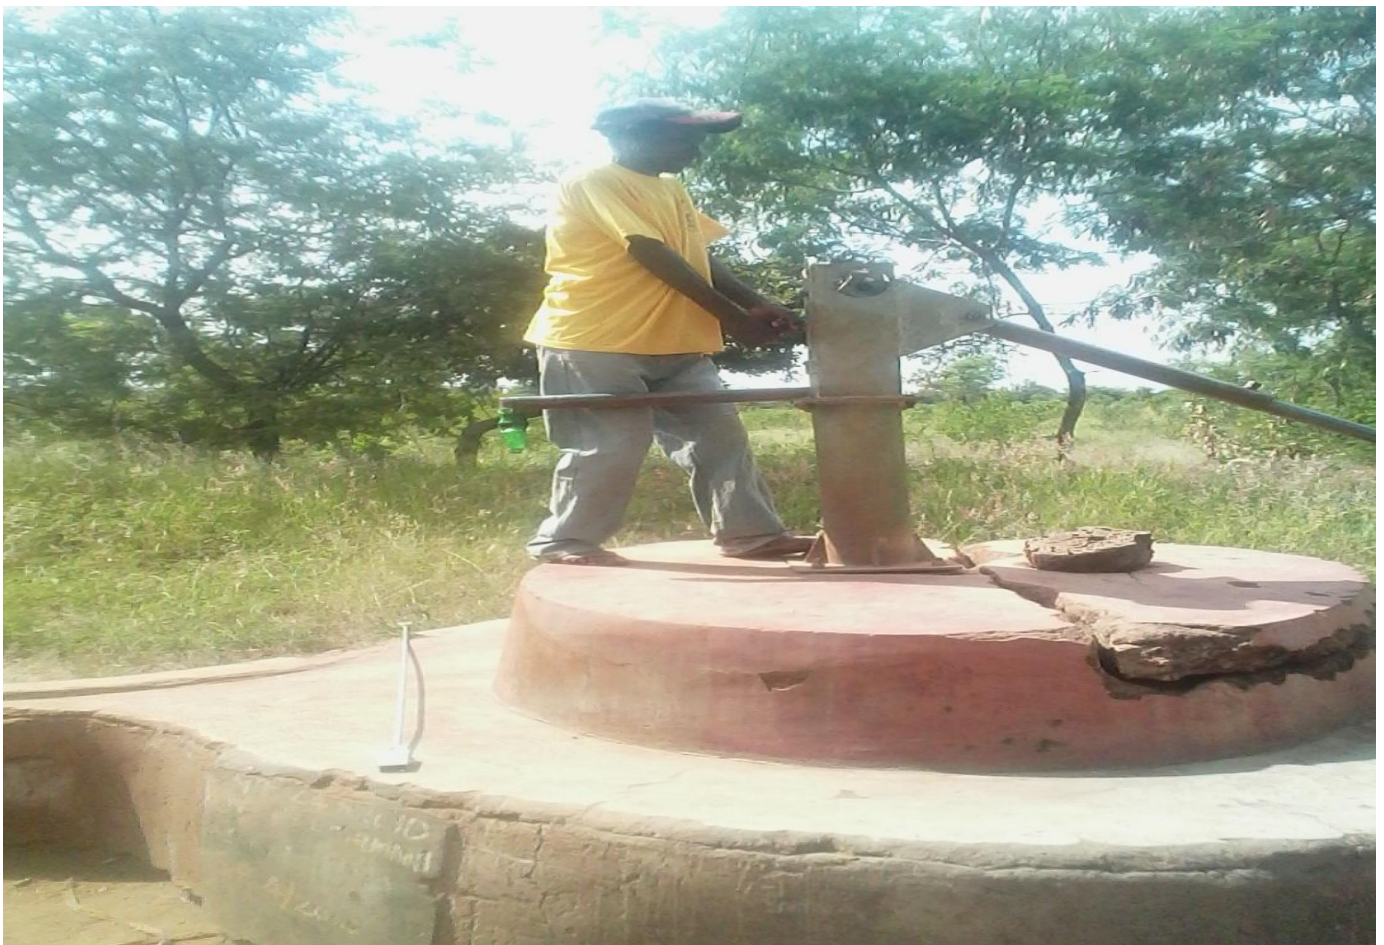
Rombo Pump. Technician and locals during repair of the pump.
