**Construction of a new school building for the  
Maromena Primary School in Madagascar**

**(FF 00358)**

**Final report**

**Feedback Madagascar/Ny Tanintsika (FBM/NT) –  
The Eagle Foundation**

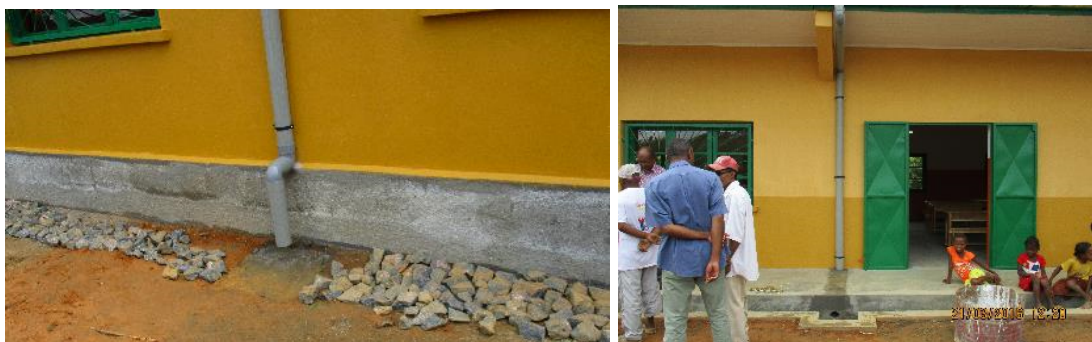
Figure 4: Additional downpipe on the school building.

- Building two buildings: One building of 3 classrooms, measuring 21.88m x 7.94m x 4.4m, and one building of 2 classrooms measuring 14.66m x 7.94m x 4,4m.
- Stone foundations and cement breezeblock walls with a reinforced concrete structure.
- Cement rendering on inside and outside walls.
- Cyclone-proof tin roofing.
- Double metal doors with hooks to hold them open on the outside.
- Each classroom with 3 windows. Windows with glass panes, opening to the inside with protection grill on the outside.
- Front and back guttering on both buildings with an additional downpipe in the middle of the 3-classroom building due to heavy rainfall in this area (to prevent damage).

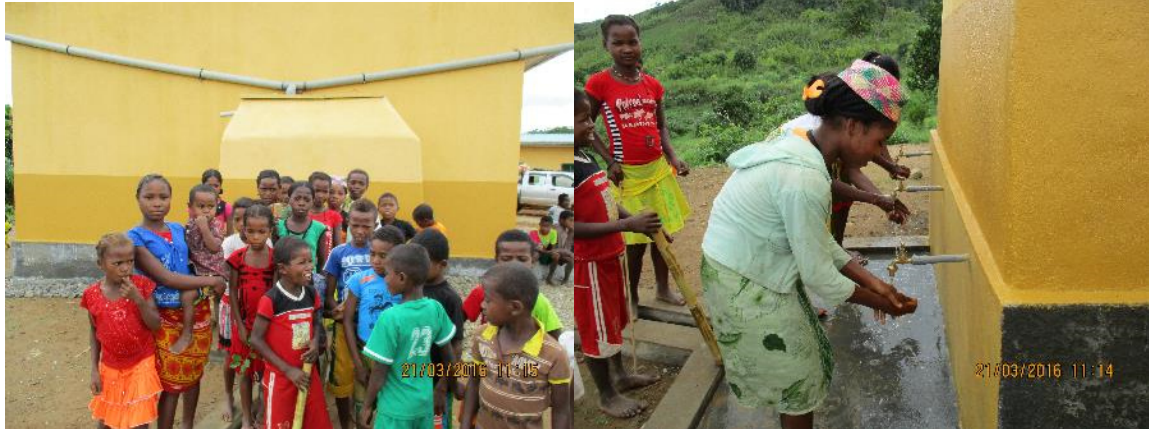
- Building guttering linking to a 3.6m<sup>3</sup> water tank for rainwater (smaller than the expected 8 m<sup>3</sup> due to a change in the design adopted by the school) serving as a hand-washing station to the side of the building, connected to 3 taps. The system is raised-up to be at a convenient height for hand-washing. This is located between the latrines and the school to promote hand-washing at key moments. The tank is equipped with a manhole cover on the top to enable cleaning as well as refill during the dry season. However, due to the school's safety worries about potential accidents to pupils, no permanent steps (with banister) were built up to the top of the water tank.

*Figure 5: Washing hands at the rain-water tank.*

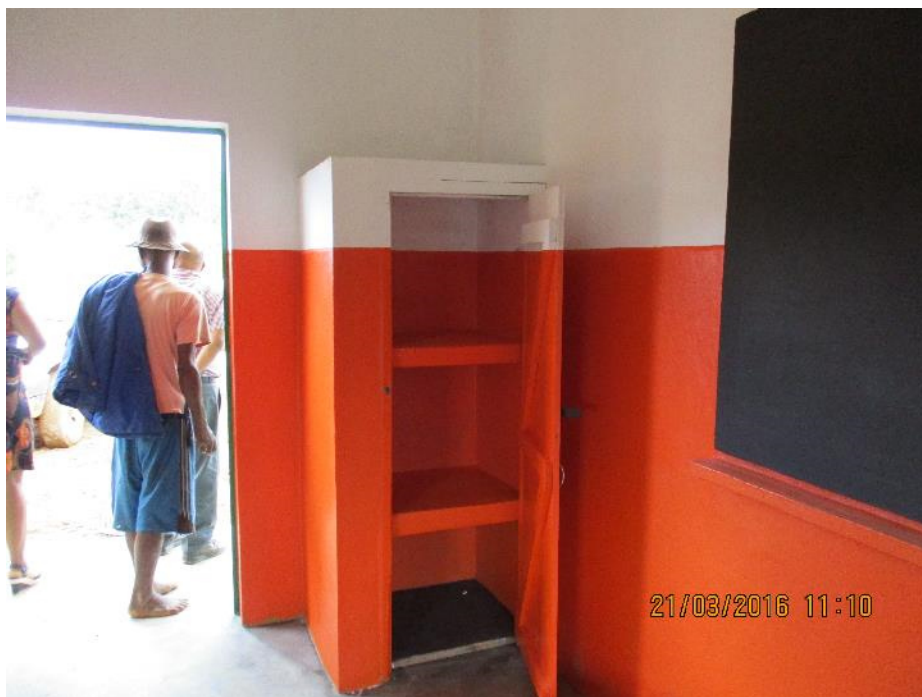
- Two-tone colouring (interior and exterior); oil paint at the base to protect from dirt and water-based paint higher-up.
- Wooden pine ceiling (of classrooms and veranda) painted with oil paint.
- Concrete blackboard with concrete chalkboard and raised stage for the teacher and their desk.
- Concrete flooring.
- In-built shelving in each classroom made of bricks, lockable with a door to store books / materials or supplies.

*Figure 6: Lockable cupboard in each classroom.*

- Installation of doors on the shelves in each classroom, so as to prevent theft of chalk, books and other materials.
- Integrating a chalk-holder shelf under the blackboard.
- Installation of guttering behind the sanitation block.
- Adding an additional concrete channel to drain water around the veranda.
- Provision of a tools kit for the school maintenance and repairs committee, who are a new structure put-in-place to improve maintenance of the infrastructure.

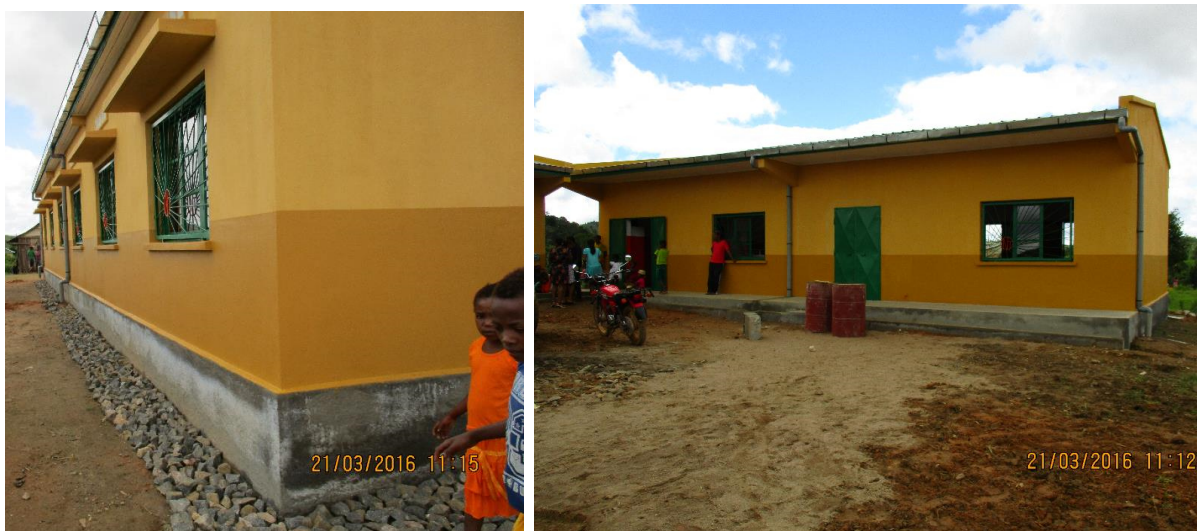
*Figure 8: Maromena Primary School.*

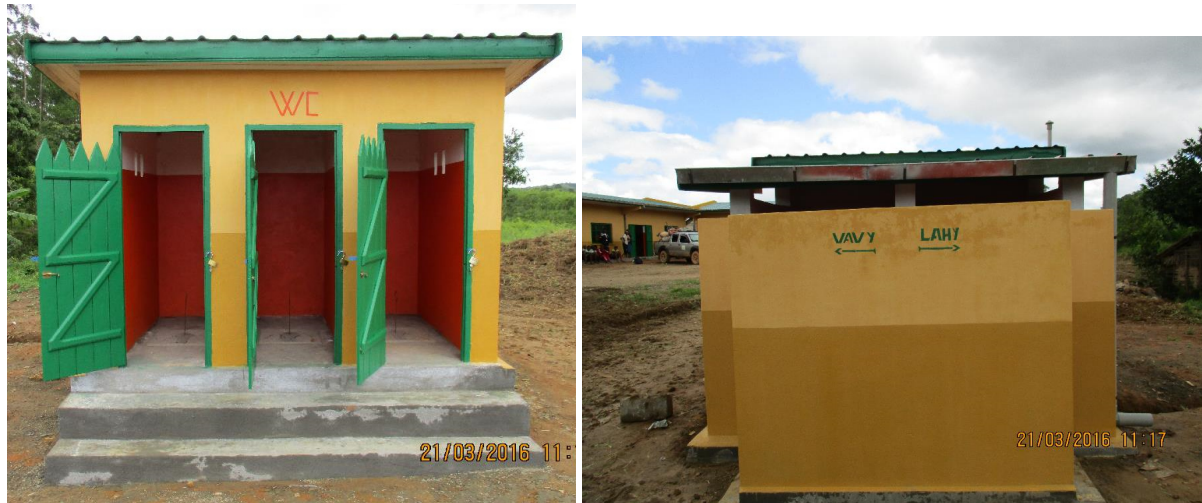
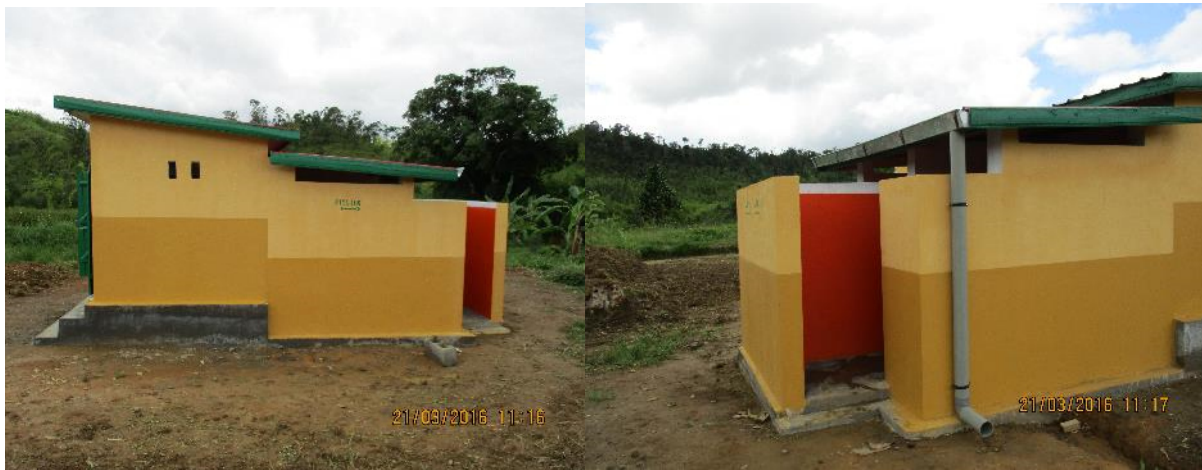
- A sanitation block composed of three-compartment washable and ‘fly-proof’ latrines (long-drop toilets with an 8m-deep hole) with separate girls/boys urinal behind. The urinals are roofed to prevent rainwater from entering the toilets (risk of damage in the cyclone season) as urine will be channelled directly into the latrine pit.
- 80 school desks with integrated benches (16 in each new classroom), 5 tables and 5 chairs for teachers.

Figure 9: Maromena School sanitation block; latrines & urinals (above & below).

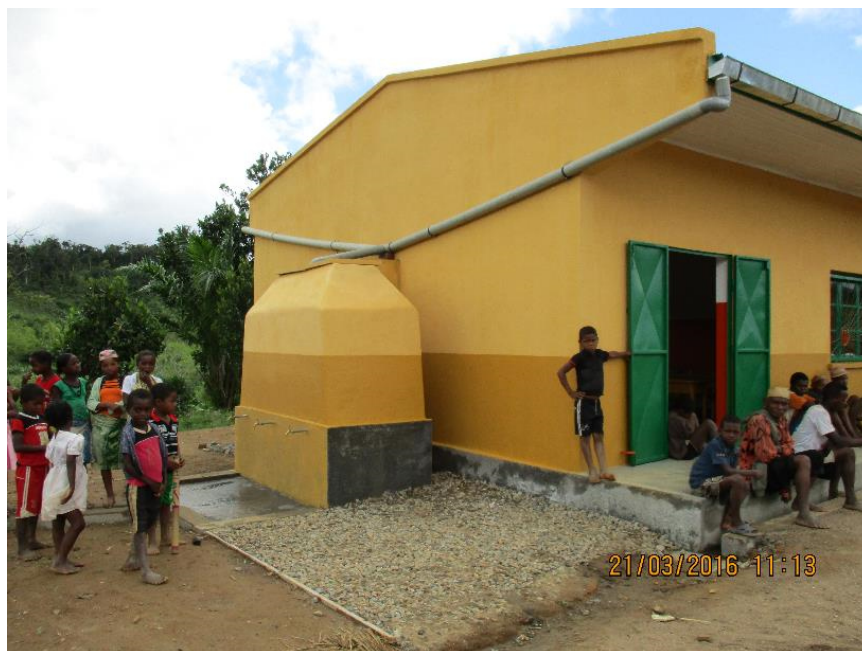
Figure 10: Maromena School impluvium / handwashing point.

- Standardise the impluvium (rainwater collection tank and system) design and size for future schools.
