1. Summary

We are pleased to present the final report on the work completed at Shree Pema Chholing Lower Secondary School, Nakote, Helambu in Sindupalchowk district. Pema Chholing is one of the three schools for which we received funding from Eagle in November as part of our reconstruction work and is one of the fifteen schools we received permission for school reconstruction from the Department of Education.

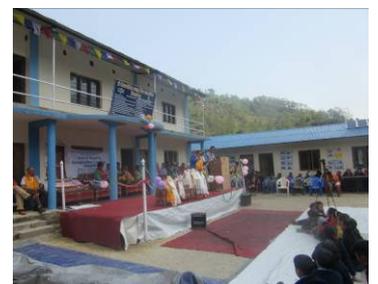
Our original plan was to retrofit seven classrooms; however, we ended up retrofitting **ten classrooms**. We rebuilt two separate toilet blocks with three cubicles each for boys and girls. A massive amount of work was carried out on rebuilding the playground using gabion wires and it was fenced off using poles and wire-mesh fencing. We also built emergency safe spaces in several locations around the school. Retaining walls were another important piece of the work we did which was aimed at providing additional support to the school building where necessary. We have installed new desks and benches to replace the broken/damaged ones. *The picture shows retrofitted building ready for classrooms use.*

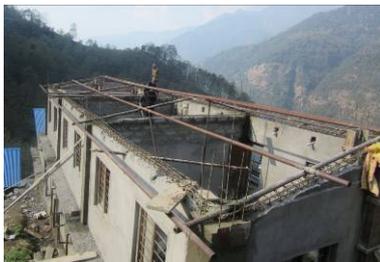
The school has three separate buildings built over the past 6 years. Two of them are two-storey buildings; one with 8 rooms and another with 6 rooms. The third one is one-storey building built for kitchen and dining hall purpose for hostel students. None of these buildings suffered irreparable damage. However, the rooms on the second floor of both the two storied buildings had intense wall cracks and the bricks had come off the walls at several points after the tremors.

whole building. Integrated with these external reinforced buttresses, we provided an additional tie beam at the plinth level all around the building perimeter. However, the other building had robust stone masonry walls on the ground floor, so only its upper floor with four rooms was treated. The pictures above left above and below right show buildings during and after the retrofitting work.

Initially, it was suggested that retrofitting was needed for seven rooms that looked unsafe, and this formed the basis of our proposal. However at a closer inspection, later, the treatment was required for 10 rooms. It was also deemed necessary to fix the other building with six rooms in its entirety to fundamentally enhance its structural integrity, strength and ductility (deformation capacity). This required external buttressing with reinforced concrete at strategic locations, especially at the joints between the walls, which has significant importance in improving the integrity of the

In retrofitting these rooms, we replaced the dislocated blocks/bricks, filled the cracks in the bands and replaced bond beams in entirety with the new ones in accordance with technical protocol. Similarly, we shifted the locations of some doors to ensure proper functioning of the load bearing walls.

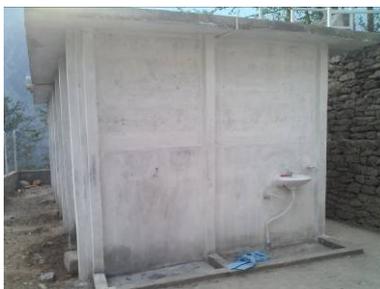
We rebuilt a new toilet building (picture left) with two separate blocks for girls and boys. Each block has three rooms with separate urinal section. The old toilet building had collapsed completely and we learnt that while it was built fairly well, the dimension of its length versus its width was unsuitable, inducing differential movements in different parts of the building. We therefore built the new toilets with two blocks separated by a seismic gap, ensuring that each has suitable length to width ratio. The new building has horizontal reinforced steel bands at different strategic levels as well as internal and external vertical reinforced ties. Reinforced

Cement Concrete Slab was used as roofing in order to accommodate a water tank that supplies water to the toilet.

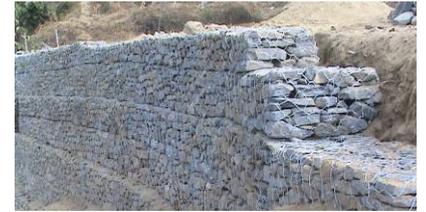
The playground measured 90 feet by 35 feet in length. It suffered large and deep cracks owing partly to the nature of the land but mainly due to the lack of a proper retaining wall. The remedy was to construct supporting walls from its base. The positioning of the school playground was such that supporting walls were required to be built with slope retention in order to protect the site from any potential landslide hazard and ground motion in the future. As the walls were built, we used gabion wires to box the stones. Soon after the playground was completed, we fenced the area using wire knitted fencing nets.
