## 1. Summary

This is the final report for the work done prior to the April-2015-earthquake and post-earthquake at **Shree Satdhara Lower Secondary school** located in Birkharka Village. Shree Satdhara is one of the three schools for which funds were requested from Eagle, as part of our reconstruction work after the earthquake. It is one of the fifteen schools that the Department of Education granted us permission to reconstruct.

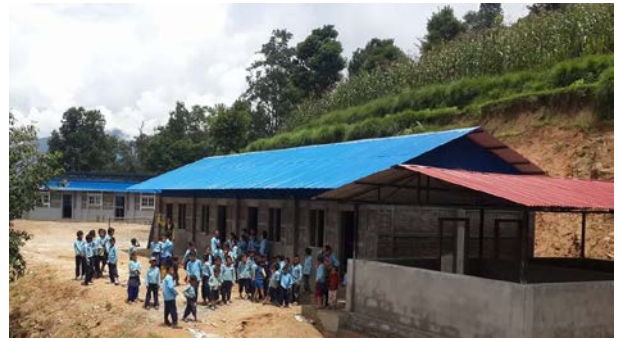
## 2.1 Classroom Construction

Please note that we built the stone masonry building because the stones were available and we were recommended by the local authorities to use local materials as much as possible as it would help transfer relevant knowledge to the villagers for when they build their own homes. We moved to brick masonry building when we saw that the stone masonry building method was taking a long time and also because the stones from the previous buildings were used up. The third building, which was built using hollow concrete blocks up to a plinth level and then walled with lightweight materials, was built to keep overall building costs low. This type of building is considered temporary compared to the other two, but is perfectly usable for at least 10 years. Whereas, the other two buildings are expected to last at least 30 years or even longer. Please do not be confused that anything built with hollow concrete blocks are to be considered temporary buildings. It is only because of the plan to use light weight material after three feet high concrete walls and that the trusses and frames were used from the Temporary Learning Centre, which means it does not quite meet the permanent school standard, however, the building is perfectly safe.

In each of these buildings, the foundations are deep and strong with concrete reinforcement. Seal and lintel bands above and below the doors provide standard seismic strength, the corner bands tie up the building joints and the walls attached to the roof have concrete beams, enabling the building to act as one unit.

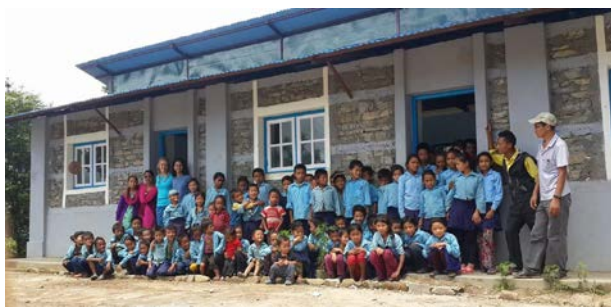
### 2.1.1. Stone masonry three room building (block I)

Out of the nine classrooms, the three rooms constructed in March are made from stone masonry and have been in use since then. In fact, this building turns out to be the first stone masonry prototype building in the region. A key feature of this building is that the roof has a south orientation, which allows heat to be absorbed during winter and for natural lighting. This building is a continuation of the building we were working on just after the quake, however with many modifications. We resumed work

Each room measures 14 feet by 15 feet and the total cost of construction for the three rooms was approximately Rs. 1,812,000 or £12,000. The cost per square feet came to approximately £19. These rooms have been in use since April.

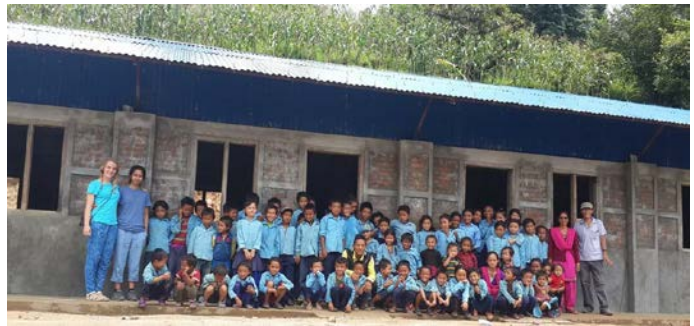
### 2.1.2 Four room single story brick masonry building (block II)

For this building, we followed a standard government model that consists of metal frame with a set of roof trusses supported by metal poles that are fixed to the ground. The walls were made from brick masonry reinforced with horizontal bands.

Following suggestions from the Department of Education, we designed this building with a light weight partitioning method suitable for smaller schools, like Birkharka, and the size of each classroom is 13 by 16 feet. The lightweight construction is to be built using a wooden stud frame, using either timber panels available from the village or plywood/cement boards on both sides. In addition, we have improved the constructional features of the building by allowing space for concrete reinforcement around the poles, increasing the size and reinforcement of both plinth ring beams and roof ring beams, and providing additional horizontal corner ties, none of which are used in the old conventional design. (See pictures below). There are a few remaining tasks for this building, including the construction of the front corridor and a ramp, the installation of door/window shutters, installation of transparent sheets and installation of light weight partitions.

After a month, towards the end of April, we began the construction of four more rooms, but this time with brick masonry. We completed the structural part of this building on the 25<sup>th</sup> of July and a few things are yet to be completed, such as the fitting of window shutters and painting. However, they are comparatively simple tasks and can be easily done.

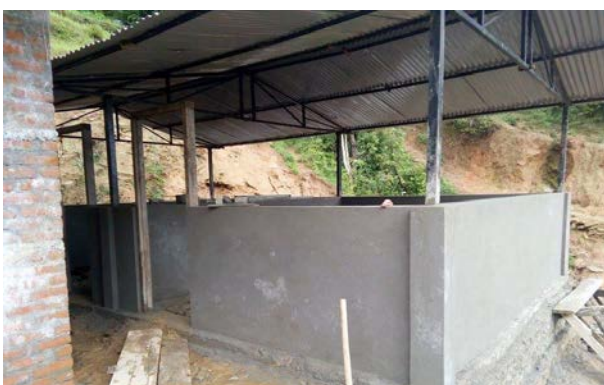
### 2.1.3 Two room hollow concrete block single story building: Admin Block

In parallel to the four room brick building, we constructed a two-room hollow concrete building, which is now almost complete apart from installing lightweight walls. We decided to go for hollow concrete blocks instead of stone or brick in order to keep the costs low, as well as to speed up the building process. Hollow concrete blocks are slightly cheaper than bricks as they are locally produced and there is no compromise with quality either. The metal trusses and roof for this building were used from

one of the Temporary Learning Centers. The walls use light-weight materials like cement boards, however the concrete block walls have been erected up to plinth level of four feet height from the DPC level (Damp Proof Concrete). We have done this because the building will be used as a library and for administration purpose and this method helped to control cost. The size of each room is 14 by 16 feet. The remaining tasks for this building are the provision of lightweight walling, the construction of an outdoor corridor and installation of door/window shutters (See pic above).

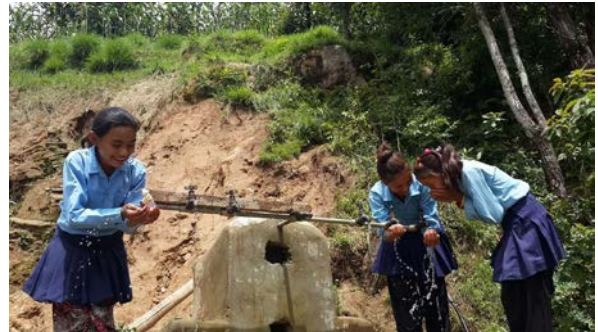
### 2.3 Drinking Water Supply

Due to the new location of the school, the need for a new drinking water supply was felt and this was our first priority. We completed this part of the project before the earthquake and it managed to withstand the disaster without any significant damage. It is now supplying water to the students in the school. We supplied 500 meters of durable water pipe and a water tank. We also built a reservoir at the water source. A temporary water tap point has been installed, but a more permanent and better one might be built near the toilet block for convenience. The cost of building water tap was £100

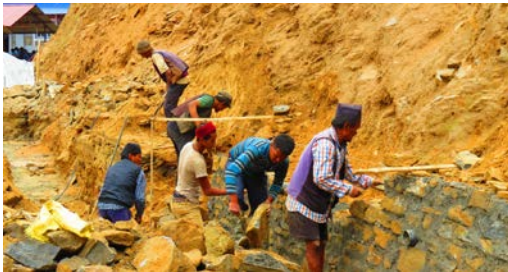
### 2.4 Playground and fencing:

The construction of the new buildings took up most of the outside space, which could have been used for a playground. Therefore, we had to create a wider outside area so that the school could have a playground. In terms of the fencing work, it was felt that retaining walls were a bigger priority, so we used the funds allocated for fencing to construct walls to prevent the soil from eroding away from the school premises when there is heavy rain.

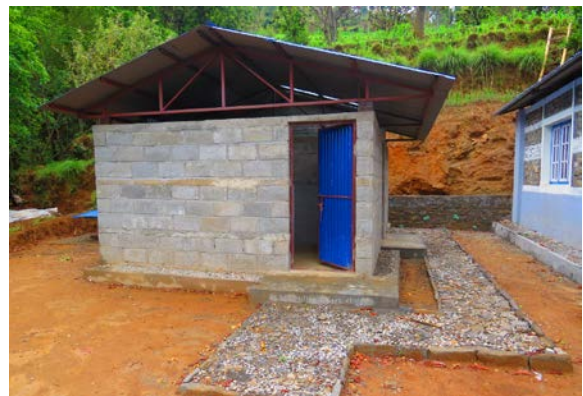
### 2.5 Toilet Construction

We have constructed a toilet building with 5 cubicles using stone masonry for the foundation and hollow concrete blocks for the walls. It has light CGI roofing, plenty of ventilation and a good water supply in the toilet. A septic tank measuring 15 feet deep and 10 feet in diameter is constructed at the back of the toilet block. The construction method is the same as the reinforced stone masonry classroom building. The toilet block has separate cubicles for boys, girls and teachers. The construction was completed in March 2016 together with the first building.
